## Incident Investigation

### Restricted Work Incident

### Well Services - Cementing

Operating at RasGas NJP Rig

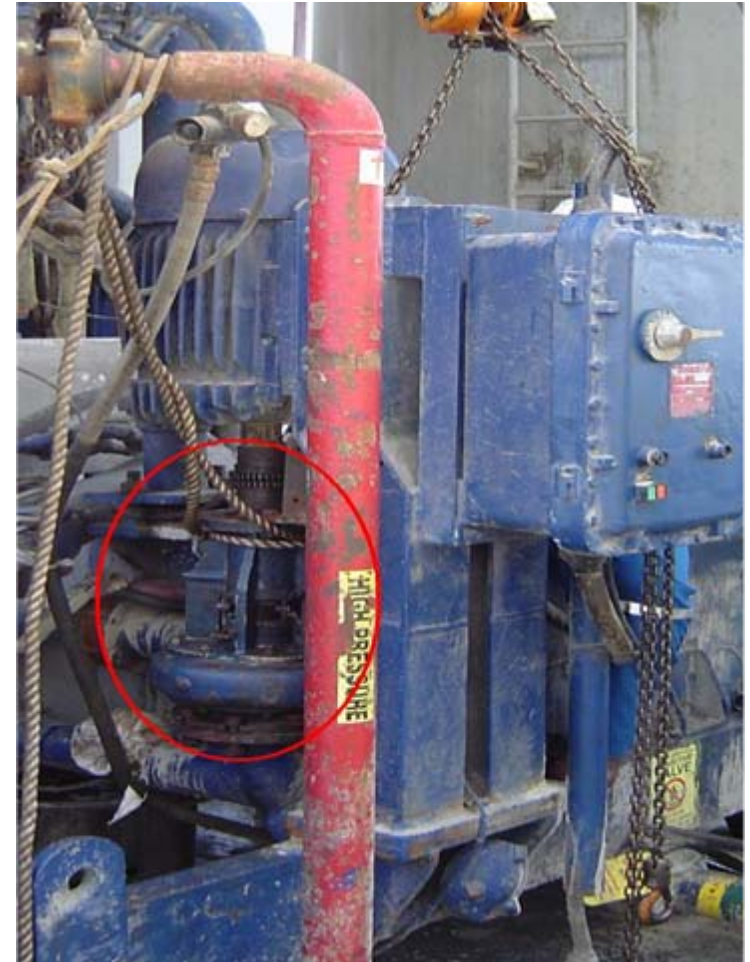
After successful completion of the 13 5/8" casing (LiteCRETE) and while performing a routine maintenance on the CPS-361 located on NJP, the Electric driven C-pump close to the mixing tub required re-packing. While attempting to remove the C-pump the operator was pushing the pump from one side while the supervisor was supporting the weight of the C-pump using a rope from the other end (Due to restrictions around the area having the mixing tub from one side and the surge tank from the other side made it a bit difficult to position a chain block right on top of the pump). The operator started pushing the pump from its frame with his right hand while his left hand was placed on top of the supporting bracket. The pump swing and caught his left hand before it was released from its position and landed in the ground slowly. The operator middle finger was affected. The supervisor performed first aid and took the operator to the Rig medic. The medic inspected his injury and requested him to leave the rig and check his left hand in a hospital. The operator left the rig the same day at noon and was taken to Hamad Hospital where they performed X-ray and provided required medical treatment. The operator left the hospital the same day. The operator reported to work the following day.

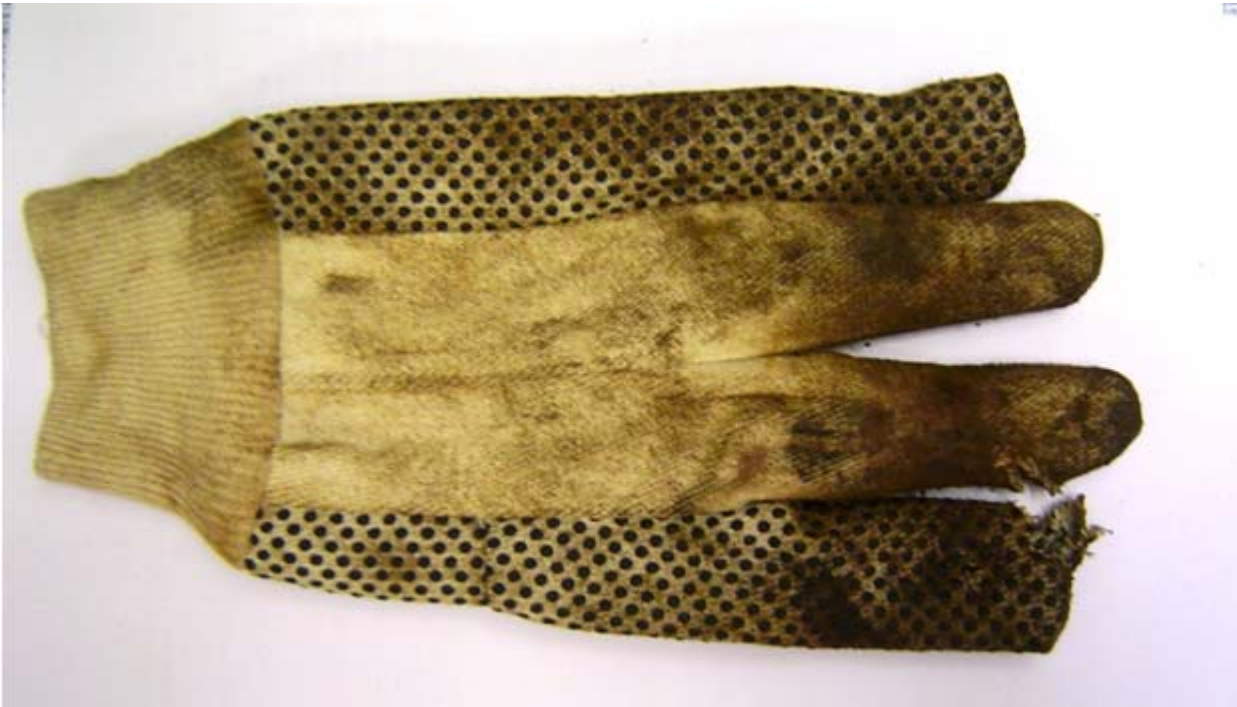
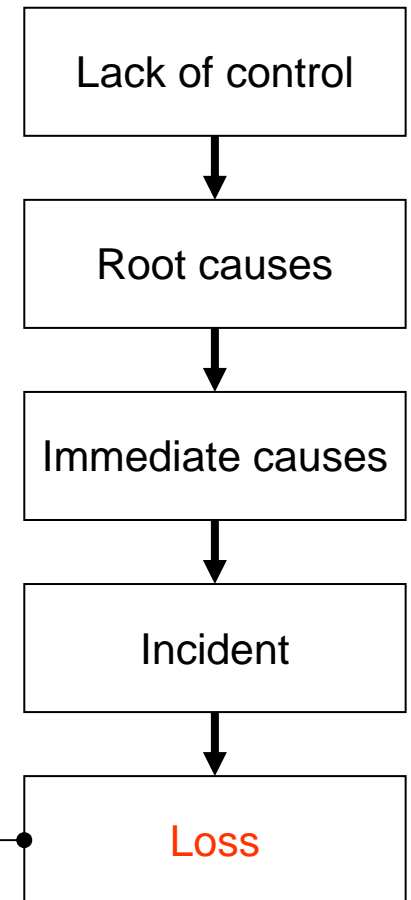
- Personnel Injury - cuts on index and middle fingers of left hand

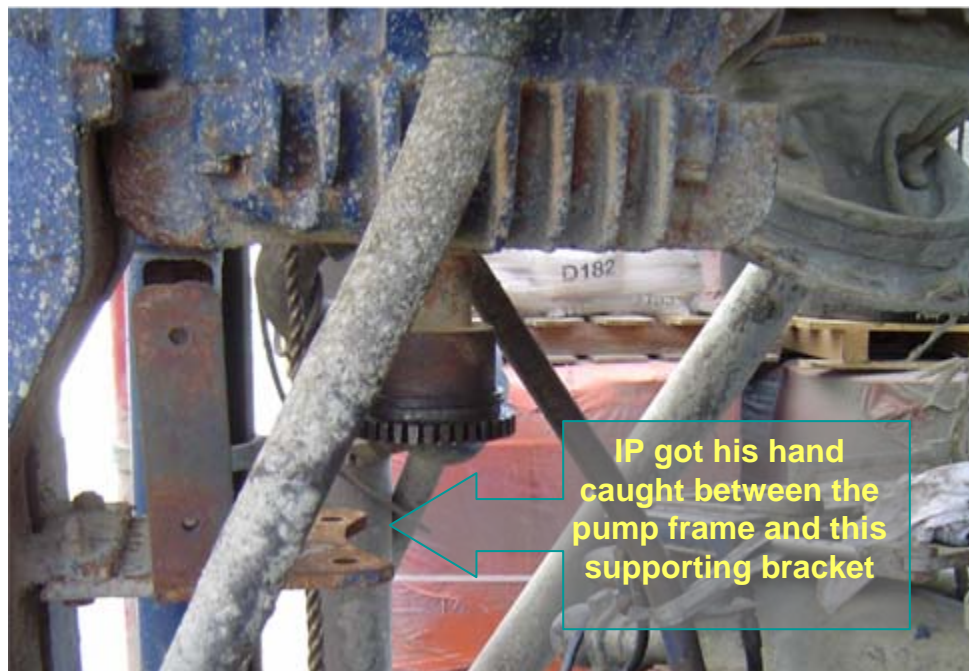
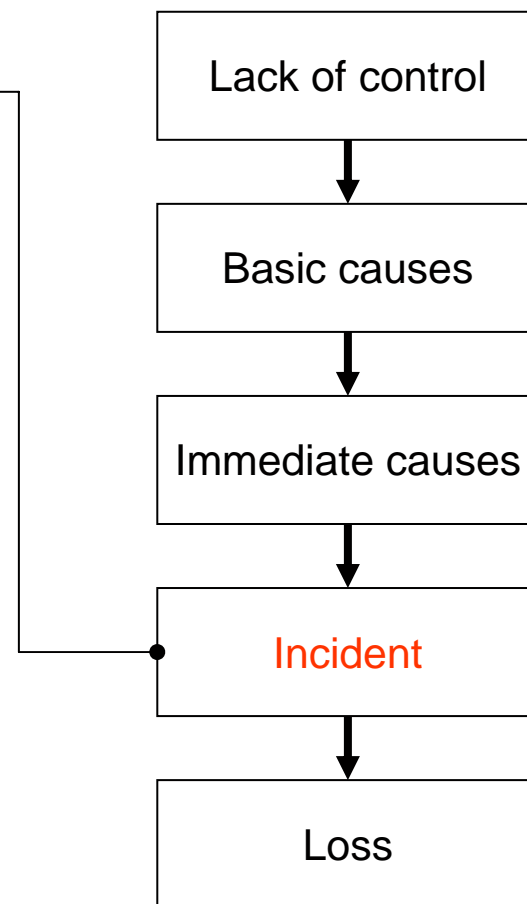
- Fingers caught between centrifugal pump assembly and pump frame

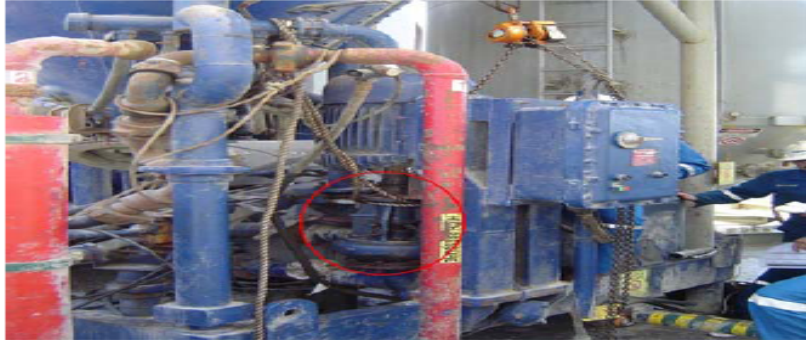
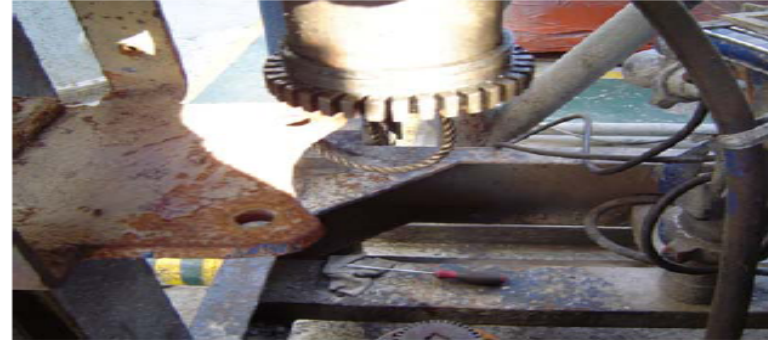
Employee injured his finger from a pinch point

This incident took place while pulling out a centrifugal pump that is mounted in a very tight space on an off-shore cement pump unit (CPS-361). The electric driven centrifugal pump is connected vertically and very close to the tub in a very tight position to circulate the slurry around the mixing system, while attempting to remove the C-pump the operator was pushing the pump from one side while the supervisor was supporting the weight of the C-pump using a rope from the other end. The operator started pushing the pump from its frame with his right hand while his left hand was placed on top of the supporting bracket. The pump swung and caught his left hand before it was released from its position and landed in the ground slowly.

- **Lack of situational awareness:** Improper position for task (Improper hand placement).
- **Lack of skill:** Infrequent performance improper lifting and handling techniques.
- **Inadequate Communication:** Step Back 5X5 and HARC was not done.
- **Inadequate development of work instruction:** Work preparation and planning is not done properly, not PTW, JSA.

- Proper SIPP techniques must be implemented all times during job.
- All maintenance jobs must be followed with detailed JSA and HARC.
- Frequent rig audits must be done.
- All employees must go through commentary task assessments.
- Awareness for implementation of safety training for day to day work must be focused to avoid this kind of incidents in future.
