***NOBLE KENNETH DELANEY
WORK RELATED INCIDENT***

**Drilling Operations Incident Review
Committee (DOIRC)**

26-Nov-2007

Type of Incident: First Aid – Work Related

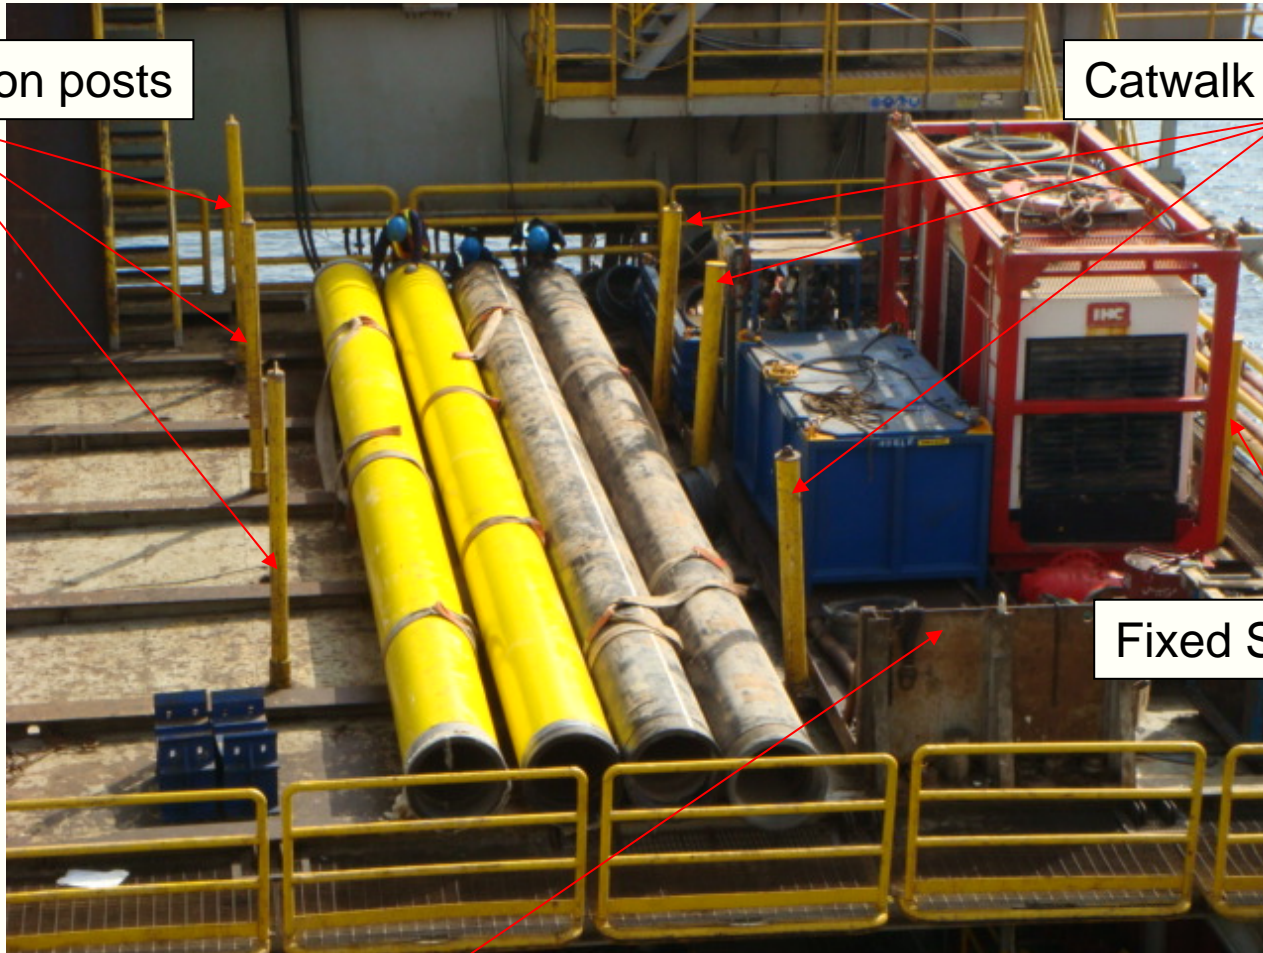
- The Sampson posts on the rig's starboard side were in place in the deck mounts. However the Sampson posts for the port side were in place in mounts that are connected on the catwalk (Giving a false sense of security – As they look the same as the Sampson posts secured to the deck). The catwalk is movable to allow for proper alignment with the v-door as the drill floor transverses into position for each well to be drilled. The catwalk was not in use at this time due to the amount of skidding going on.
- The upper cantilever deck had two basket containers and a gas bottle rack stored on the catwalk, and approximately 2 1/2' of open deck space, a 5" DP pup joint was along side a BJ hydraulic power unit that was flush against the permanent stanchion post on the port side of cantilever.

Fixed Samson posts

Catwalk Samson posts

Movable Catwalk

- Review and document the review of Noble Rigging & Lifting Manual Section 5 (Safe Approach to Lifting) and Section 23 (Handling Rig Floor Equipment) with all personnel.
- Remove Samson post slots from catwalk to ensure this will not occur again, nor give a false impression of safety for personnel working on the upper pipe rack
- Supervisors who have not already attended will be scheduled to attend formal Supervisor training
- Risk assessment and hazard awareness training held for all personnel
- Revise the Job Safety Analysis to include proper chocking of conductor pipe as it is being layered

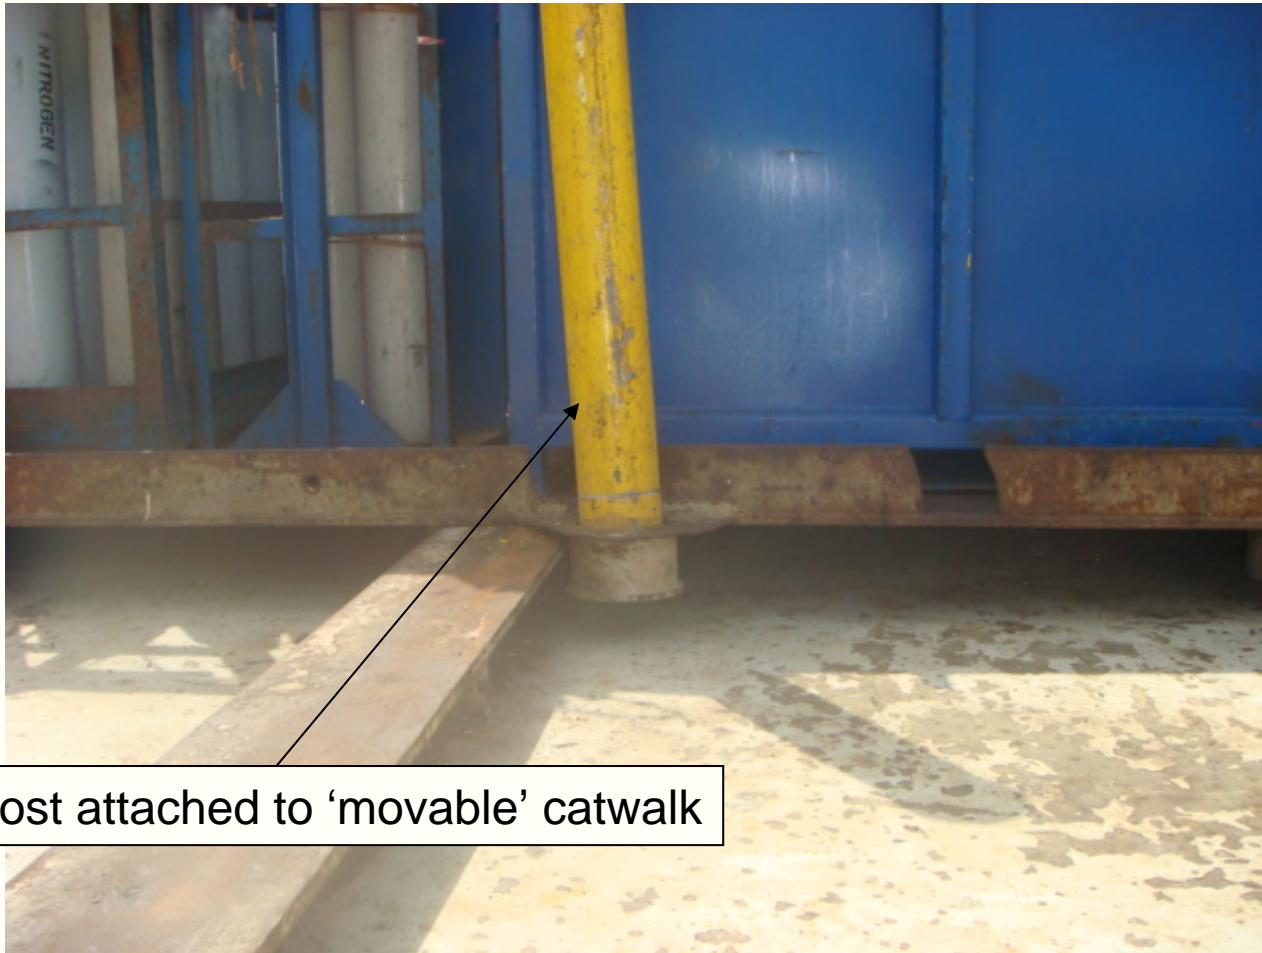
Samson post attached to 'movable' catwalk

- 1-The catwalk was used as a stop for the conductor pipe, and personnel involved in the task failed to realize that it was not designed to serve as a stop for tubulars racked in the way they were. (Inadequate Engineering, Inadequate Risk Assessment)
- 2- The Sampson post on the catwalk gave personnel a false sense of security.
- 3-The Job Safety Analysis did not identify the hazard of the catwalk moving when weight from the conductors was applied against it. (Inadequate Risk Assessment)

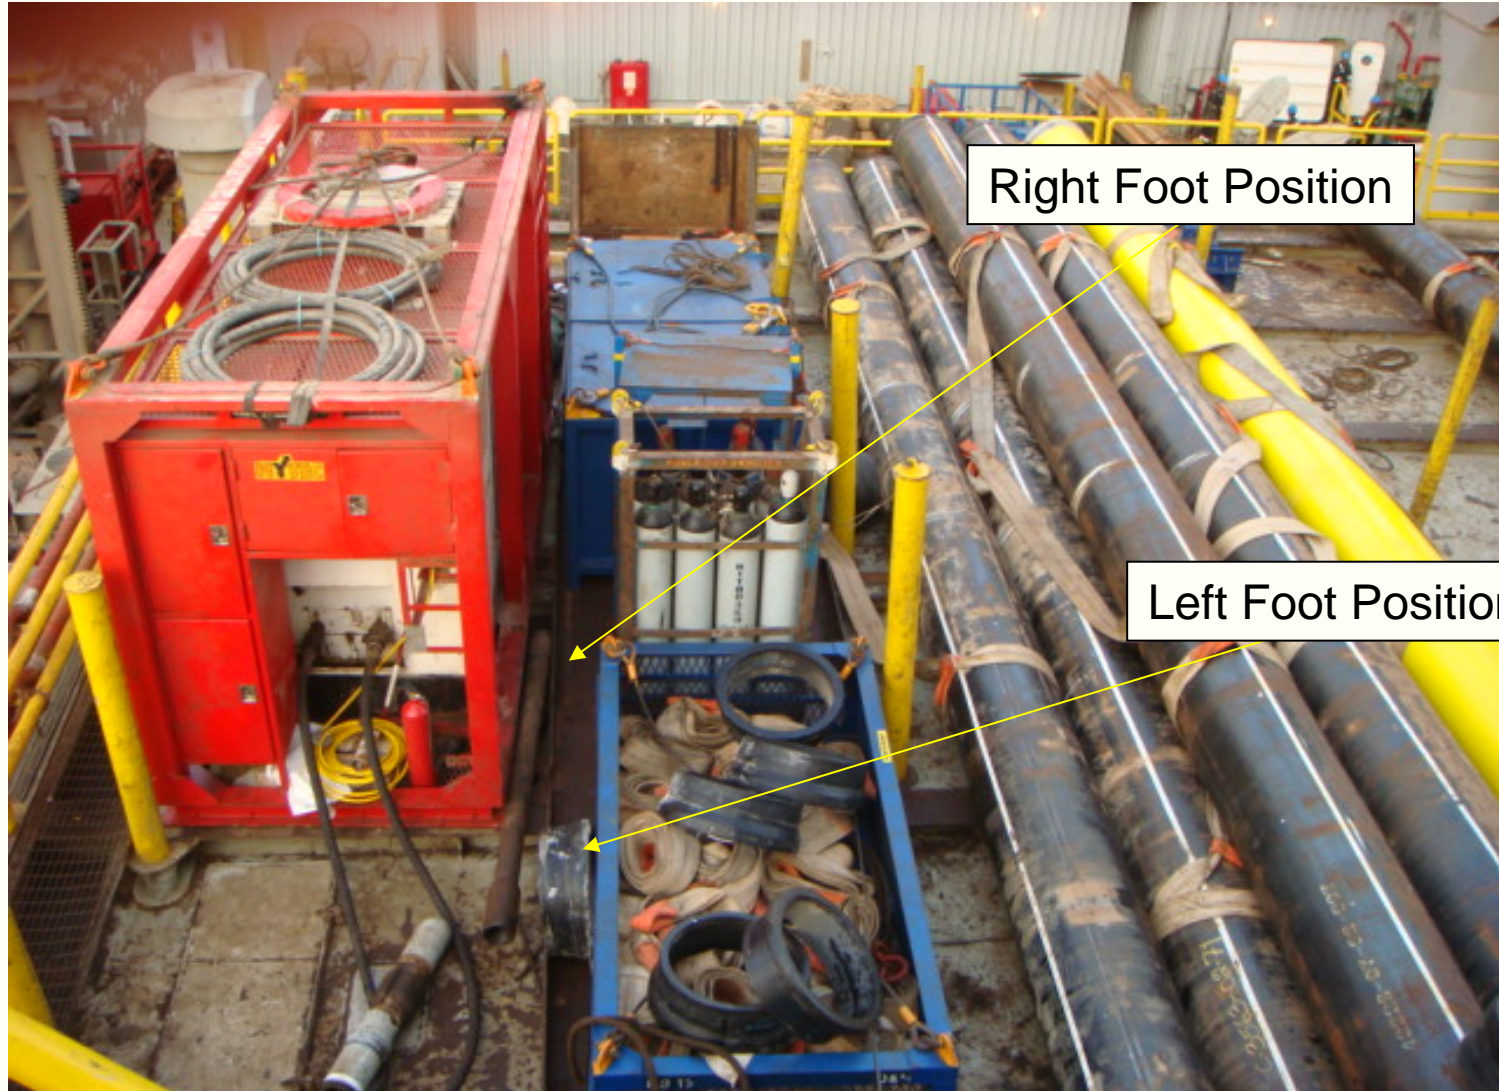
- The injured person was holding a tag line and walking between the catwalk and the hydraulic unit, getting into position to remove the sling and the tag line from the conductor pipe. At this time the catwalk slid toward the port approximately 2 1/2 feet . It trapped the injured person's foot between the drill pipe pup joint and the catwalk.
- The Banksman noticed the movement of the catwalk and immediately had the Crane Operator lift the load back up.

Right Foot Position

Left Foot Position

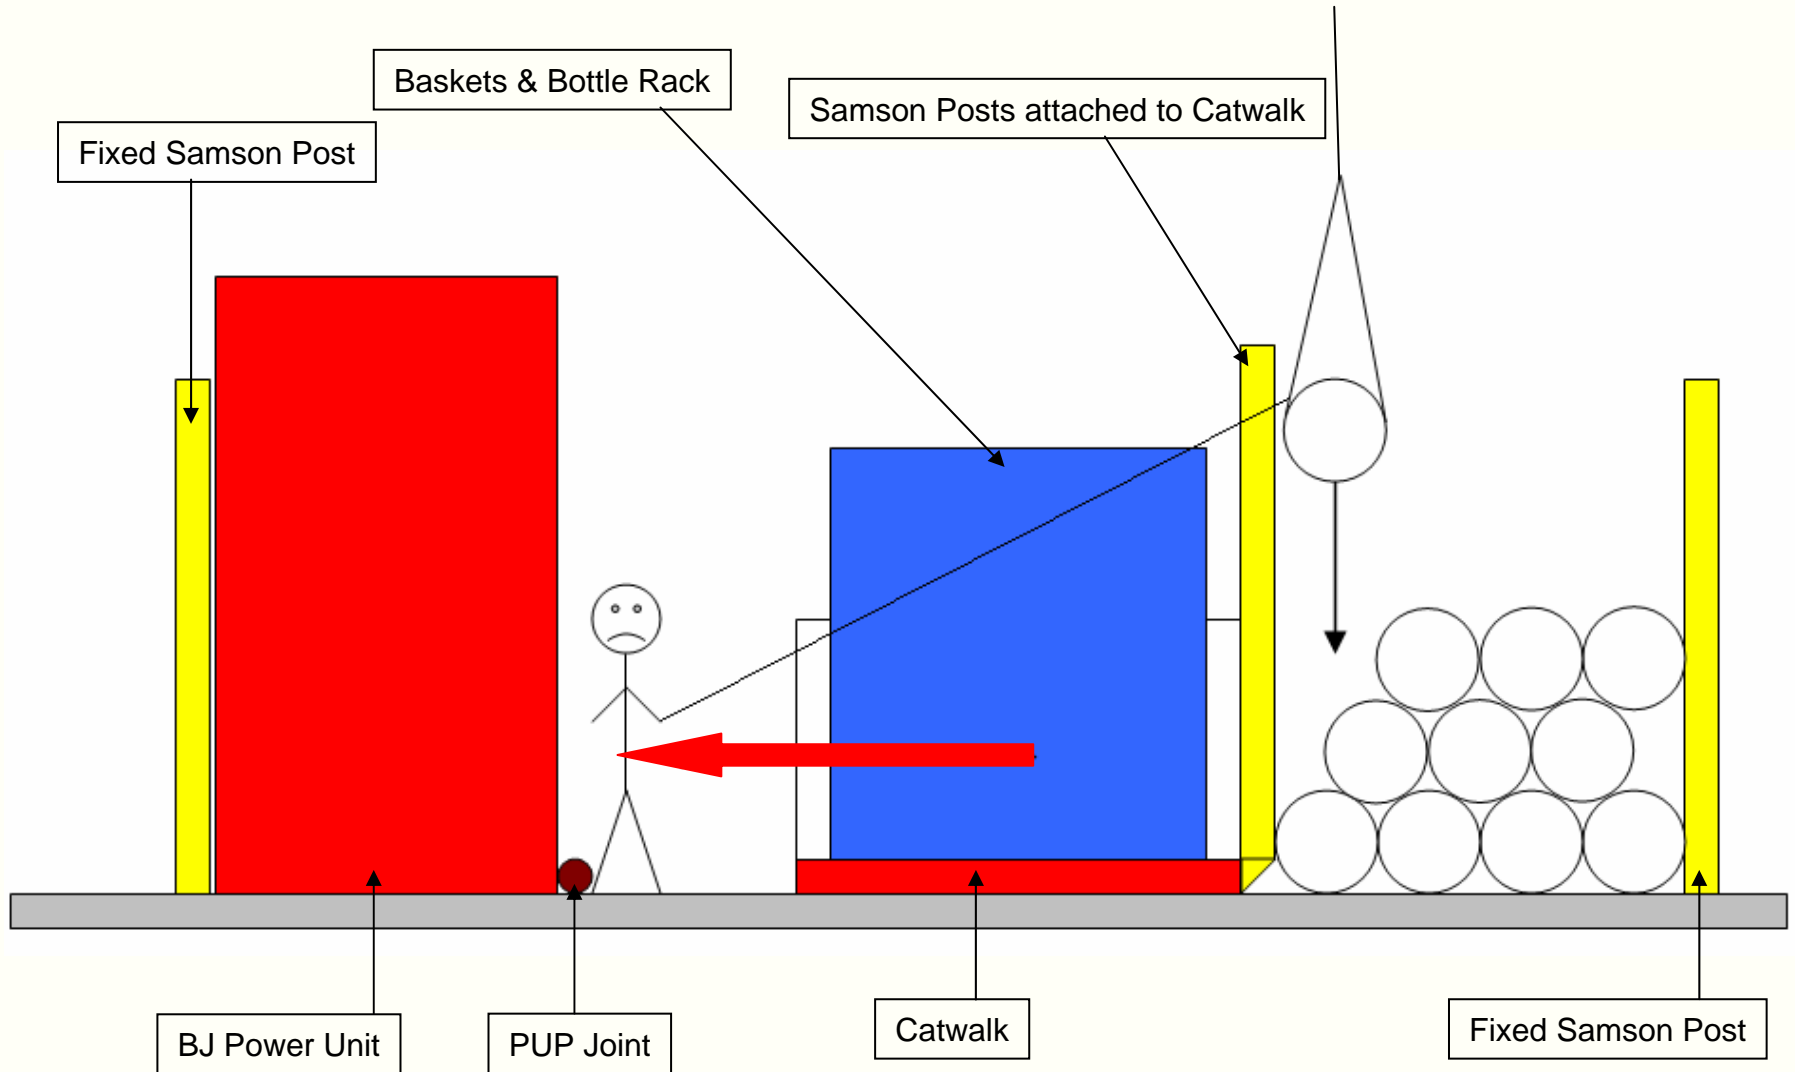
LOOKING FROM DIRECTION OF RIG FLOOR TOWARDS ACCOMMODATION

- In the bay there was enough space for 4 joints of 26" conductor pipe to fit. So 4 joints were fitted in the bottom layer. 3 joints of 26" conductor were placed on top of these 4 joints to form a second layer. And another 3 joints were on top of these to form a third layer. The Crane Operator placed one more joint in the gap of the second layer, as this joint of conductor pipe was put into position the catwalk slid due to the weight of the conductor pipe against the catwalk Sampson posts.
