# INCIDENT 1

<b>Rig Involved:</b>	Al-Zubarah
<b>Date of Incident:</b>	23-Sept-2008
<b>Time of Incident:</b>	01:30hrs
<b>Rig Operations:</b>	Running in Hole 5 ½” DP
<b>Rating of Incident:</b>	Near Miss (Property Damage)

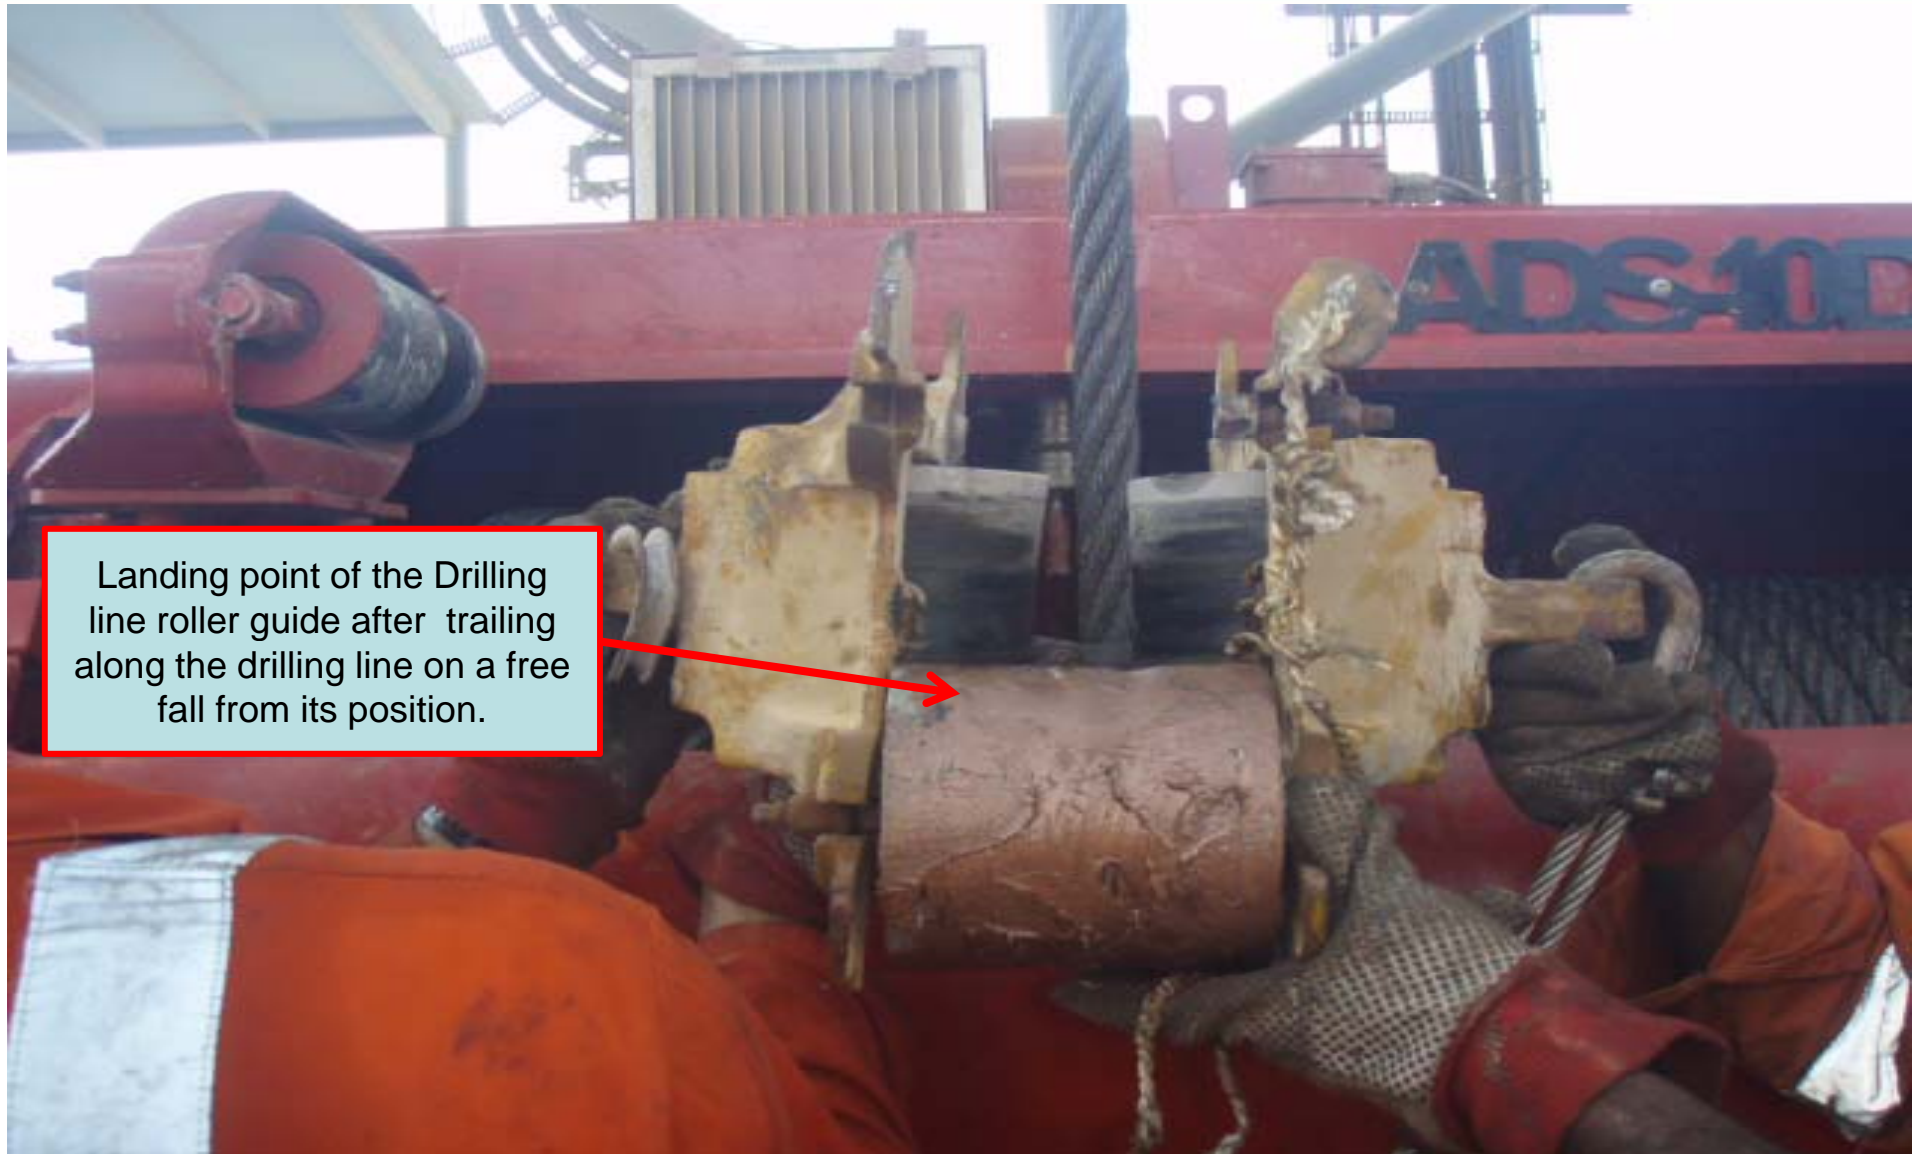
# Landing position at the Draw works.

At about 6500ft, the roller guide dropped from position, (above monkey board level) slipped down along the drilling line and landed on the draw works.

Landing point of the Drilling line roller guide after trailing along the drilling line on a free fall from its position.

- All routine inspections are now being supervised by sectional supervisors and reports verified for by GDI Rig Superintendent for correctness before signing off.
- There is an ongoing feasibility study in consultation with the derrick manufacturer to determine the possibility of removing the drilling line roller guide from service without any safety consequences.

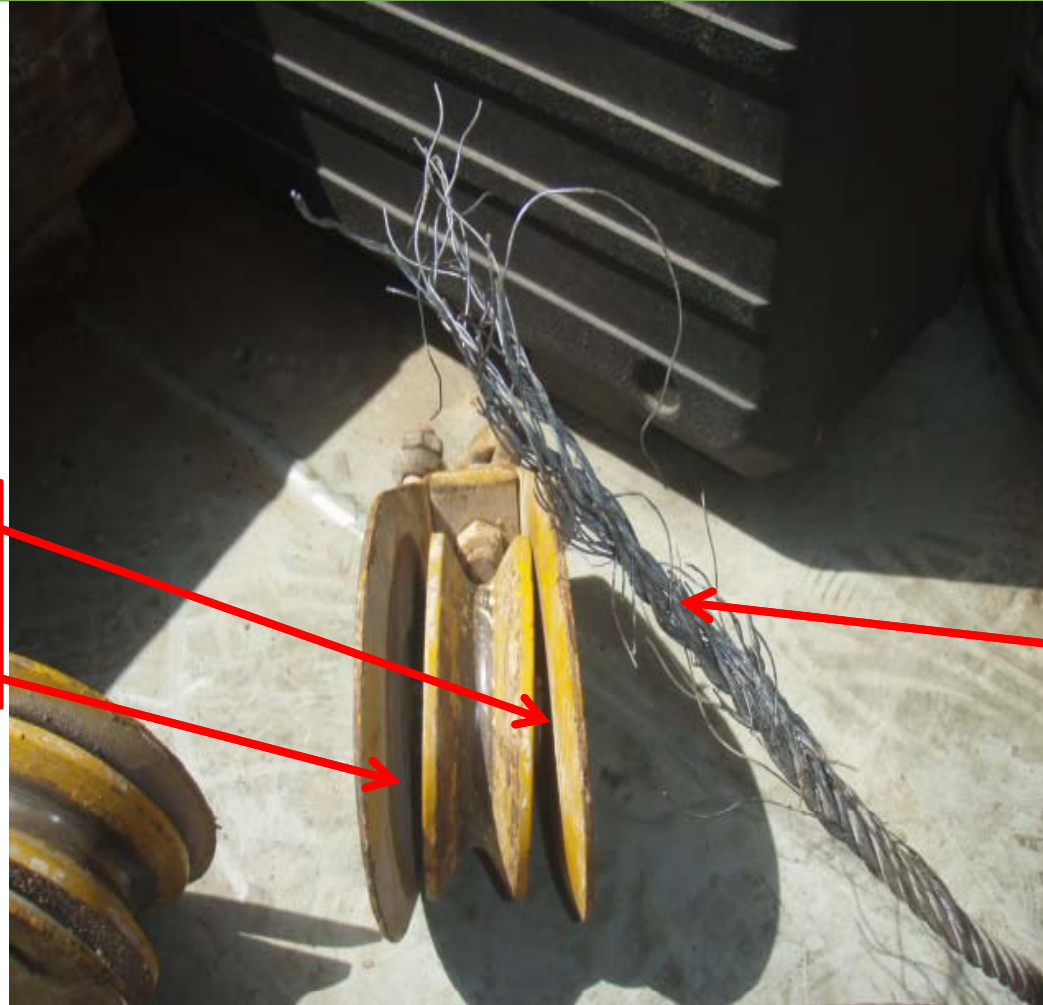
# Faulty Sheave and Broken hang off wire

Visible defects on sheave which subjected sling to mechanical impact.

Hang off wire of the drilling line roller guide assembly which broke as a result of wear & tear impact from faulty sheave.

Hang off wire broke on stabilizer unit.

Poor condition of sheave was undetected due to awkward position of roller guide assembly (about 120ft outside of derrick) without service platform. This caused the inability to fulfill detailed regular inspection criteria as required.

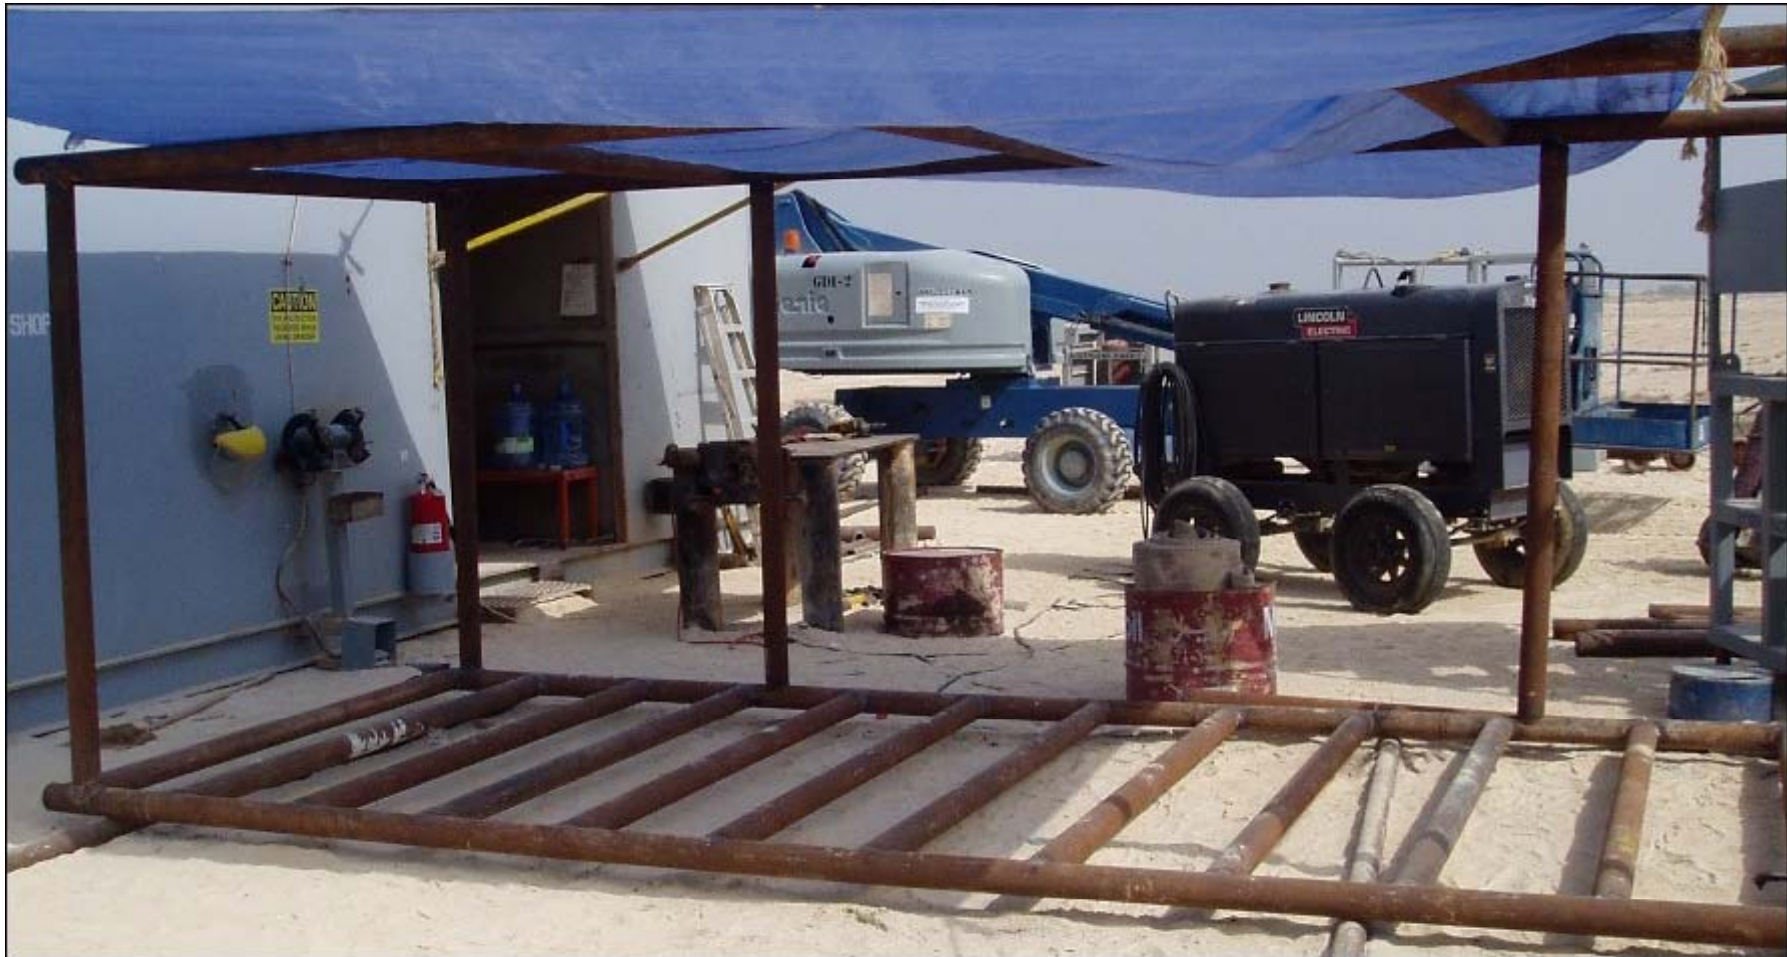
# Foot Injury

- While fabricating stand for travelling block the pipe for the vertical section of the stand toppled down hitting the welder's left foot

- Pipe was not supported properly during adjustment and alignment.
- Bottom part of the pipe was not tack welded before making adjustments for alignment.

- **Include full hazard identification.**
- **Proper planning of job**
- **Ensure sufficient personnel available for job.**
