QATARGAS 3&4 UPSTREAM SAFETY PERFORMANCE Q4 2008 & 1Q 2009

Sammy Rose
HSE Specialist

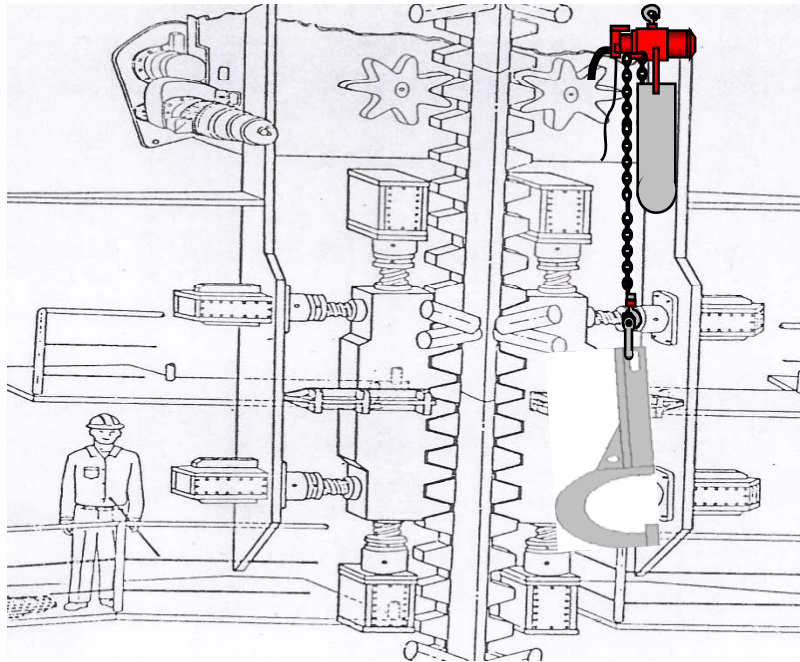
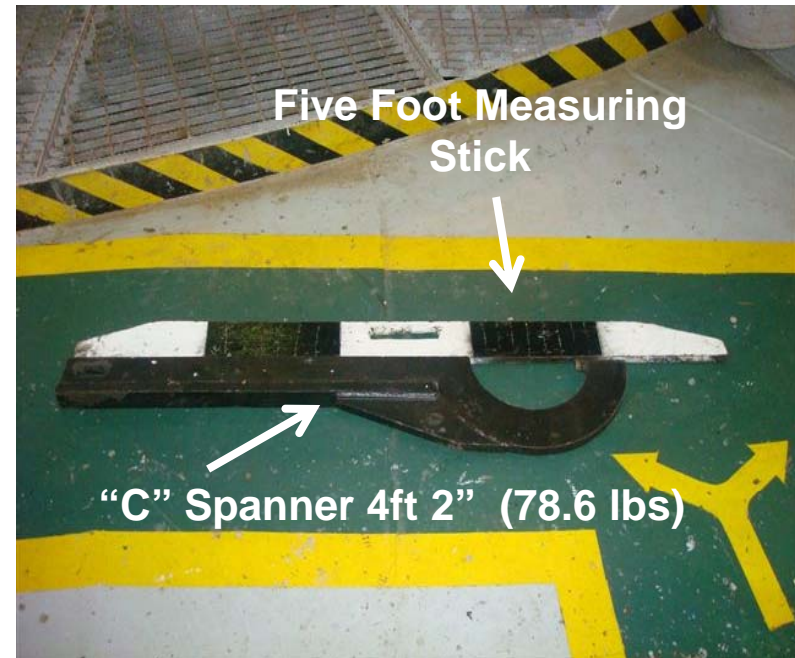
Lost Time Incident – Noble Kenneth Delaney – 6th February 2009

Binod Shrestha injured his back while moving heavy spanner (78.81Lbs). At end of TBT IP proceeded to the paint locker to collect the tools. While picking up a newly supplied "C" spanner by himself for this operation and transporting to the bow leg, Binod sustained a back injury. Binod did not report injury at the time & TBT was held in English with a little translation given. Decision made to send Binod ashore for further medical evaluation.

- I1 Heavy Tool (“C” Spanner 78.6 lbs and 4ft 2” in Length)
- I2 One Person Lifting

- U1 Lack of Maintenance (Rack Chocks)
- U2 Failure to Conduct Risk Assessment for New Equipment/Tools
- U3 No formal Manual Handling Training (for IP)
- U4 No Formal basic training requirements identified by Noble
- U5 No Pre-Contract Audit Conducted on Petronet prior to Supplying Personnel
- U6 Inadequate Risk Assessment
- U7 Failure to Appoint Buddy System
- U8 Meetings Conducted In English

- R1 Inadequate Risk Assessment Training Provided
- R2 Communications and Language Barrier
- R3 Failure to Implement HSE-MEA-SOP 803 Contractor Management

1. Re-design "C" Spanner for Jack Screws with light weight Alloy metal.(Tool was cut down and reduced in weight by 25 lbs and risk assessed prior to re-using Temporary measure only)

2. Manual Handling Training for all personnel(employees/contractors)
3. Jack Screws to be cleaned and properly lubricated and covered once re-installed
4. Implement risk assessment for all new tools/equipment

5. Noble to formally communicate basic training requirements to contractors for personnel assigned to there Rigs
6. Conduct a Audit of Contractors in line with HSE-MEA-SOP 803 Contractor Management

7. Initiate Buddy System when personnel are assigned to tasks outside there normal scope of Work
8. Review and Revise JSA 0300-000371 Rack Chock and Jack Screw- Function Test

9. Review and Revise JSA training material for suitability
10. Rig Induction, Safety meetings and training to be conducted in dual language when required
