MAERSK OIL QATAR AS DRILLING DEPARTMENT SAFETY STATISTICS Q4 2009 – Q1 2010

DOIRC Meeting Q1 2010

MOQ Safety Performance

Q4 2009 – Q1 2010

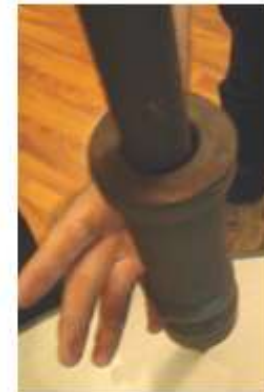
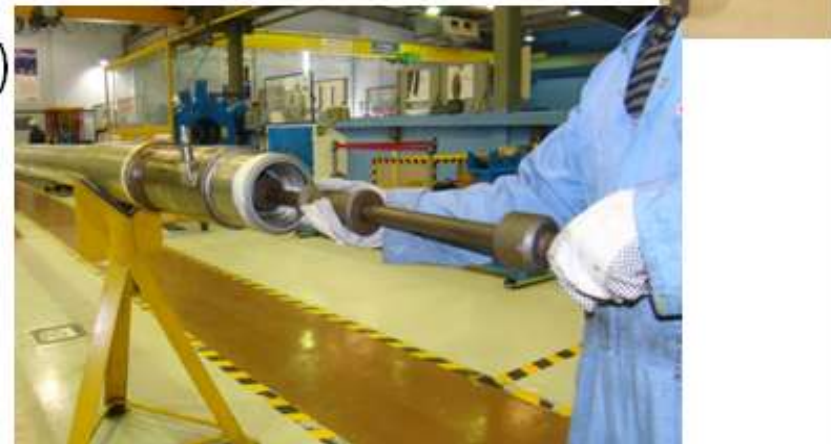
- Field engineer was using the slide hammer trying to remove the float valve from the Xceed bit box held vertically in the rig floor. The hammer slid and pinched his finger

- Heavy Duty Slide hammer designed to be used only when the tool was horizontal
- Fatigue

- New design (Puller to remove float values)
- Safety Alert to be sent out to the field
- Fatigue management recertification for all
