TapRoot Investigation

11th March 2010

Schlumberger Wireline – Ensco-88

IP sustained laceration on his right leg shin

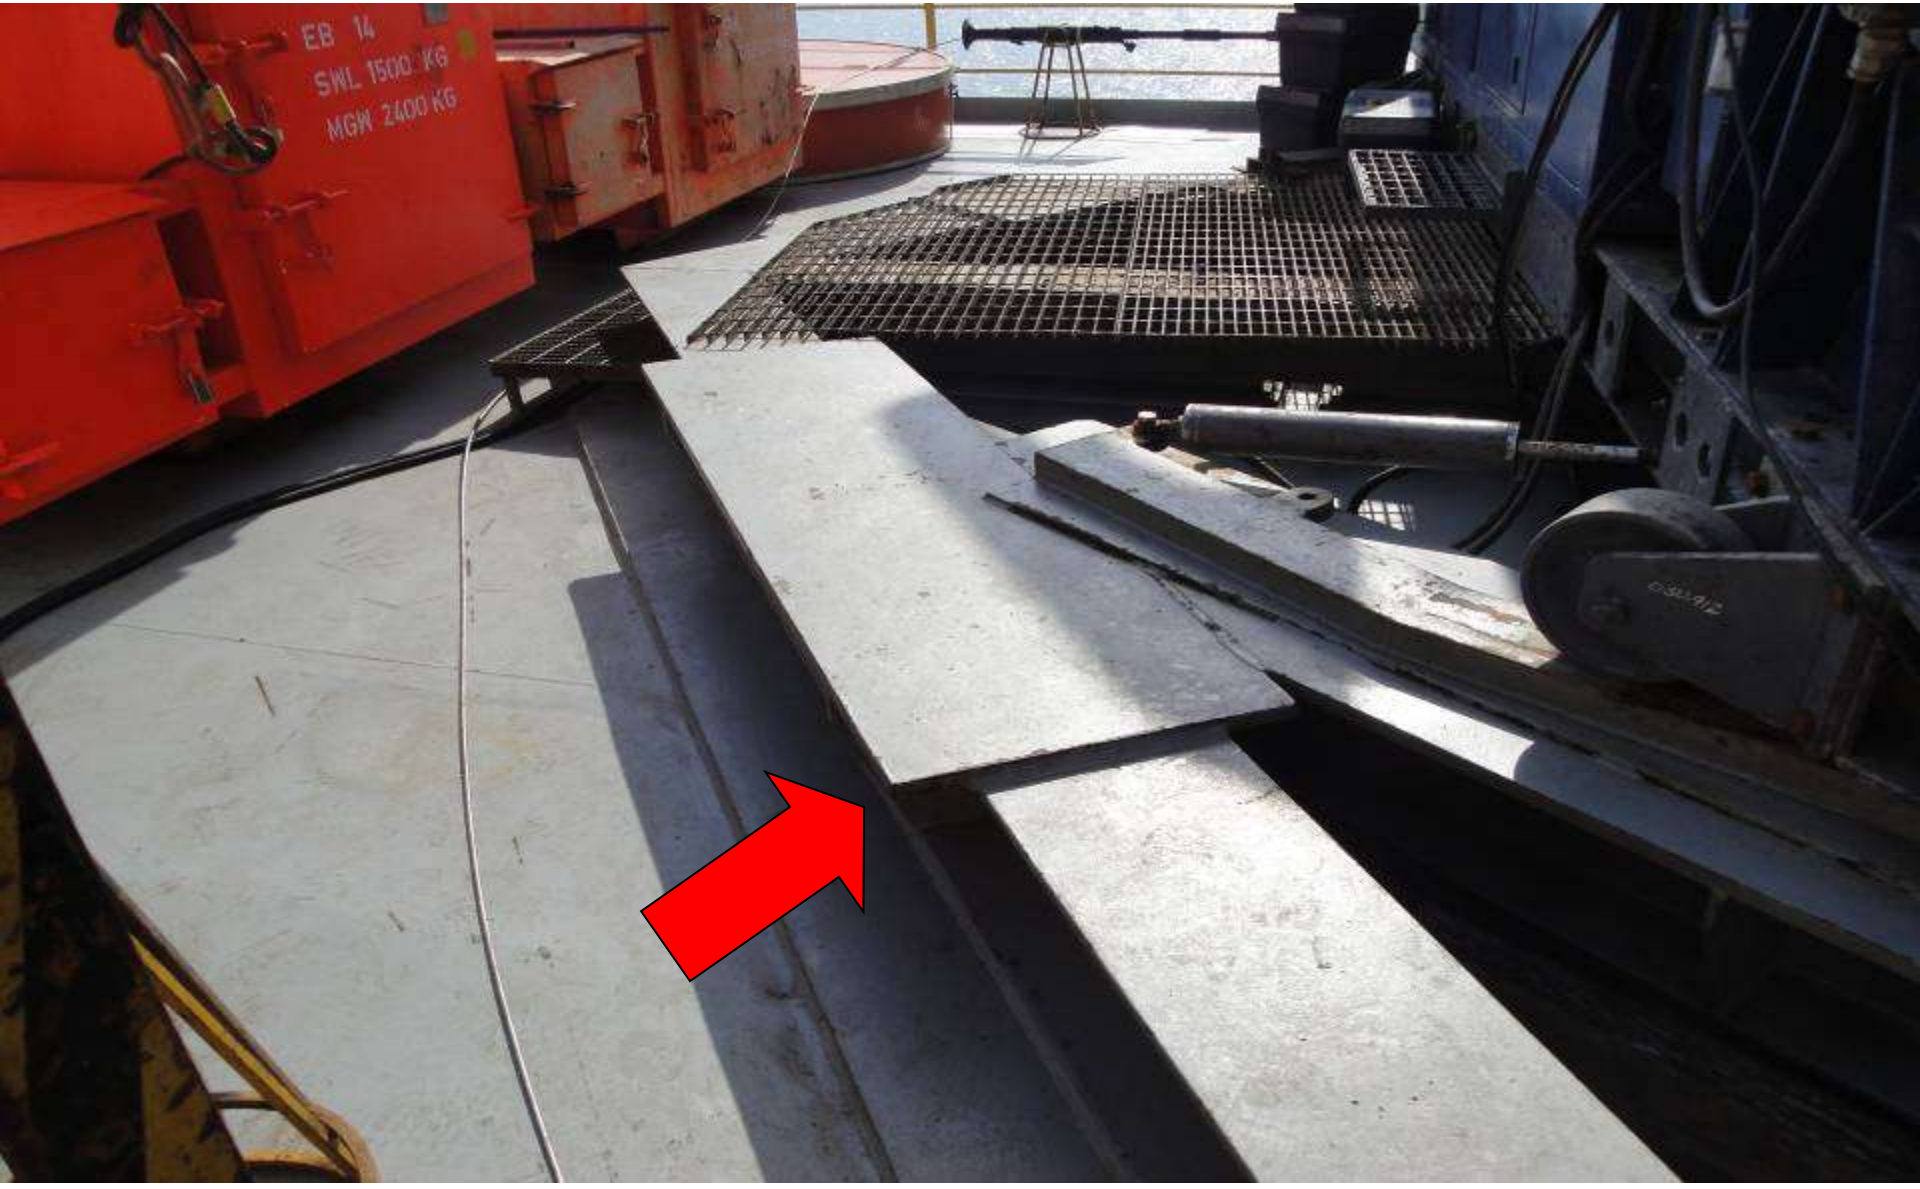
- On March 11, IP was working on wireline unit engine to replace an ESD valve.
- The IP notices a difference between the new and old ESD, IP then decides to go inside the wireline unit to seek advice from his supervisor
- IP walks around the unit from engine area towards the entrance and steps on 12” support beam instead of stepping on access step located 7 feet away.
- As he steps on the support beam, IP trips and falls with his right leg shin hitting a sharp corner of the support structure’s top plate.
- IP is taken to the rig hospital. His wound was cleansed and dressing was applied.
- After evaluation, decision is taken to Medivac IP.
- IP received 4 stitches and returned to work on normal duties the following day.

Root Cause	Corrective Action	Due Date	Responsibility
<p><u>Design specs</u> <u>Problem not anticipated</u></p>	<p>File all sharp corners on unit support structure</p>	<p>14 Mar 10</p>	<p>Ensco 88 OIM</p>
	<p>Paint support beam with black and yellow stripes</p>	<p>31 Mar 10</p>	
	<p>Investigate sharp corners of unit support structure on other rigs in RasGas fleet for corrective action</p>	<p>31 Mar 10</p>	<p>SLB Ops mgr</p>
