Qatar Shell Well Delivery

Annulus Well Barrier Compromised: Procedure not followed for Annulus VR Plug Removal

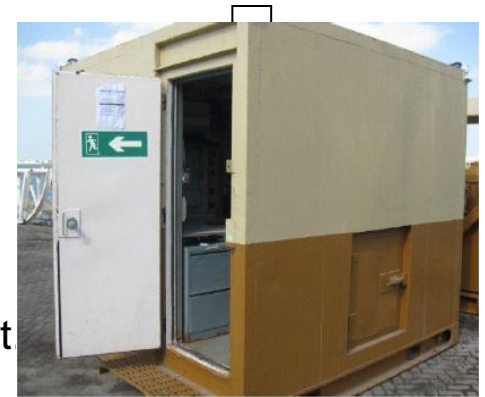
- A containerised office/workshop delivered to the off Supply Base for the rig
- The delivery included the necessary manifest and certificates.
- The container was loaded on a company trailer for delivery to the port
- The container was loaded onto the deck of the supply vessel.
- When the lift was completed it was noticed the **actual** weight was exceeding the gross weight
 - the weight information was mentioned on all documentation
 - gross weight 6 Tons, actual weight 7.5 Tons

- Contractor assumed that the actual weight was not exceeding gross weight
- Over time installed equipment was replaced and additional items were added
- The net weight was not updated
- Staff trusted the weight mentioned on manifests and certificates
- Crane operator did not notice the actual weight exceeded gross weight

- Ensure that **accurate** weights are manifested with all containers and baskets sent to the port.
- Manifested weight to be verified against crane load indicator reading (actual weight)
 - when? - immediately after lift is hanging free from trailer bed/vessel deck.
- Lifting and Hoisting checklists must identify the moment and need to verify manifested weight against actual weight.

- Hold an awareness meeting with all Contractors
 - Objective: improve quality of manifesting correct weight
- Review all checklists
- Review update level of discussion in in the pre job safety meetings (TRIC/TBT)

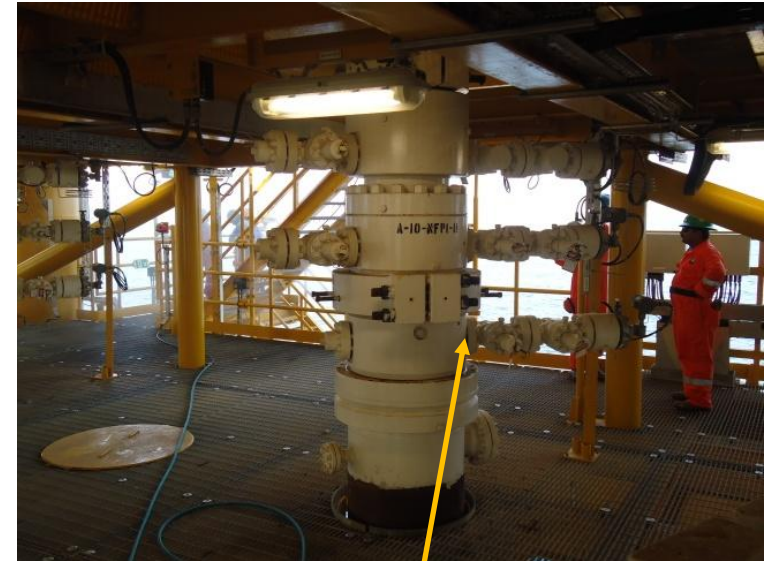
Short VR Lubricator Tool

1. While using 'short' VR Lubricator Tool (under dispensation with 1 Side Outlet Valve only) the instructions were to inflow test the VR plug for an extended period.
2. This inflow test was cut short and the VR plug removal was started without notifying the C&WI Supervisor.
3. After breaking out the VR Lubricator Tool it was noted that the VR Plug was not recovered.
4. Concluding that the VR plug was lying loose in the Side Outlet Valve, a 'Dry Rod' was used to retrieve the VR plug. This time without using the VR Lubricator Tool and thus breaking the well barrier envelope.
5. To ensure engagement with the VR plug the 'Dry Rod' was turned to the left after which a backflow of annulus fluid (inhibited water) was noted.

- Technician used to carry out tasks independently and rely on experience rather than procedures.
- There was an element of self-imposed pressure to get the job done.
- Safety Tools (Risk Register, TRIC, STOP, JSA) not used to their full benefit.

- Ensure instructions, procedures and risks are well understood and test they are well understood through 'open questioning'.
- Give more ownership to the contractors while using the Safety Tools and C&WI Supervisor to take on a coaching role.
- Engagement required with C&WI crews regarding the 'Meaningful' use of Safety Tools.

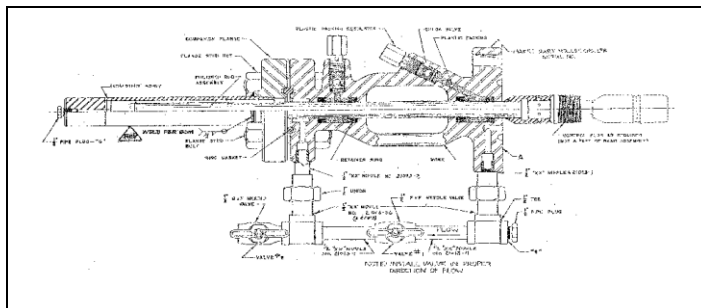
VR Plug Installed in Wellhead on A-annulus 'live side' of well NFP1-11.
Note: at time of VR plug removal only 1 Side Outlet Valve was present due to maximum stroke of 'short' VR Lubricator Tool
