# Fall from Height Incident

**Incident Date:** 21-Aug-11

**Rig Name:** GDI-4

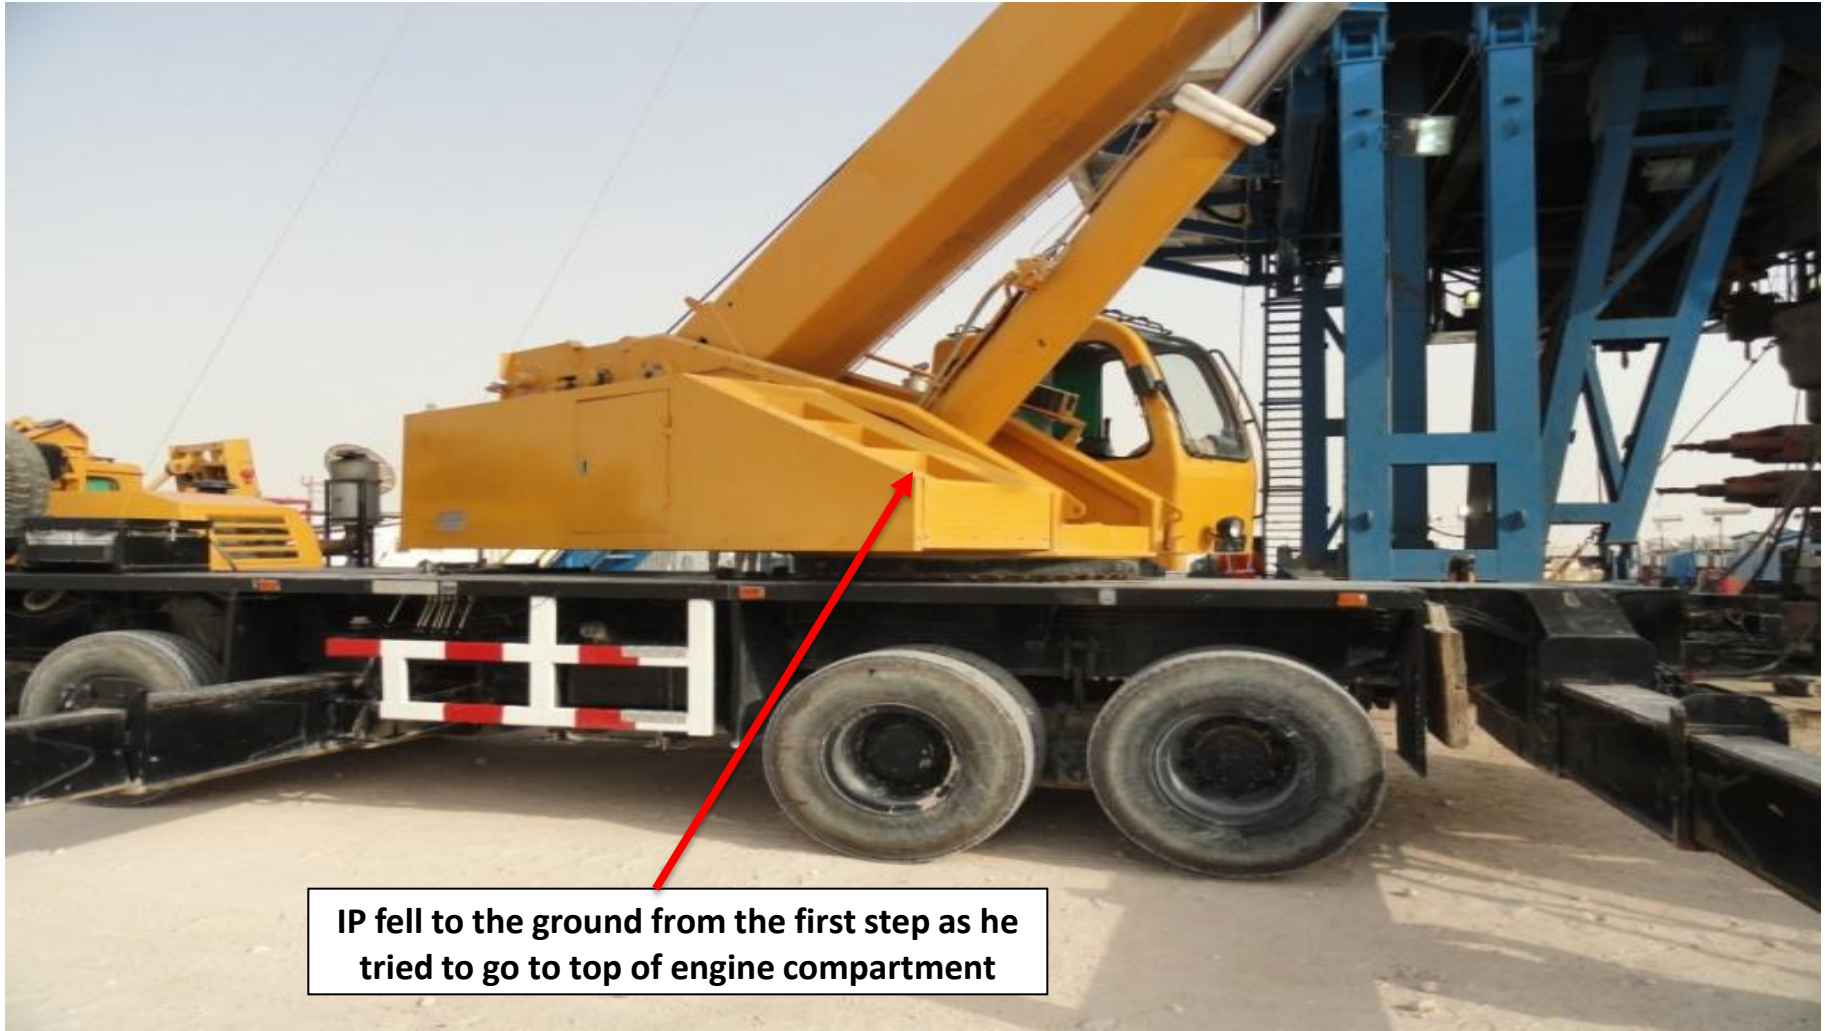
At 22:00hrs, Rig operation was laying down drilling tools by crane. The crane was kept at standby and its top structure was swung out from the crane deck (refer picture).

# Picture 1: Crane position and rear steps when incident occurred.

IP fell to the ground from the first step as he tried to go to top of engine compartment

- ✓ Risk awareness training for Crane Operators and maintenance crews.
- ✓ Cascade safety alert and discuss at weekly safety meetings.
- ✓ Ensure anti skip are always maintained anti skid.
- ✓ Review and revise procedure to include section on correct positioning of crane before commencing any maintenance and ensure procedure is implemented by crew.
- ✓ Carry out engineering feasibility study on installing hand rails along the steps and the top of engine compartment and consult manufacturer for modification to prevent similar incident.

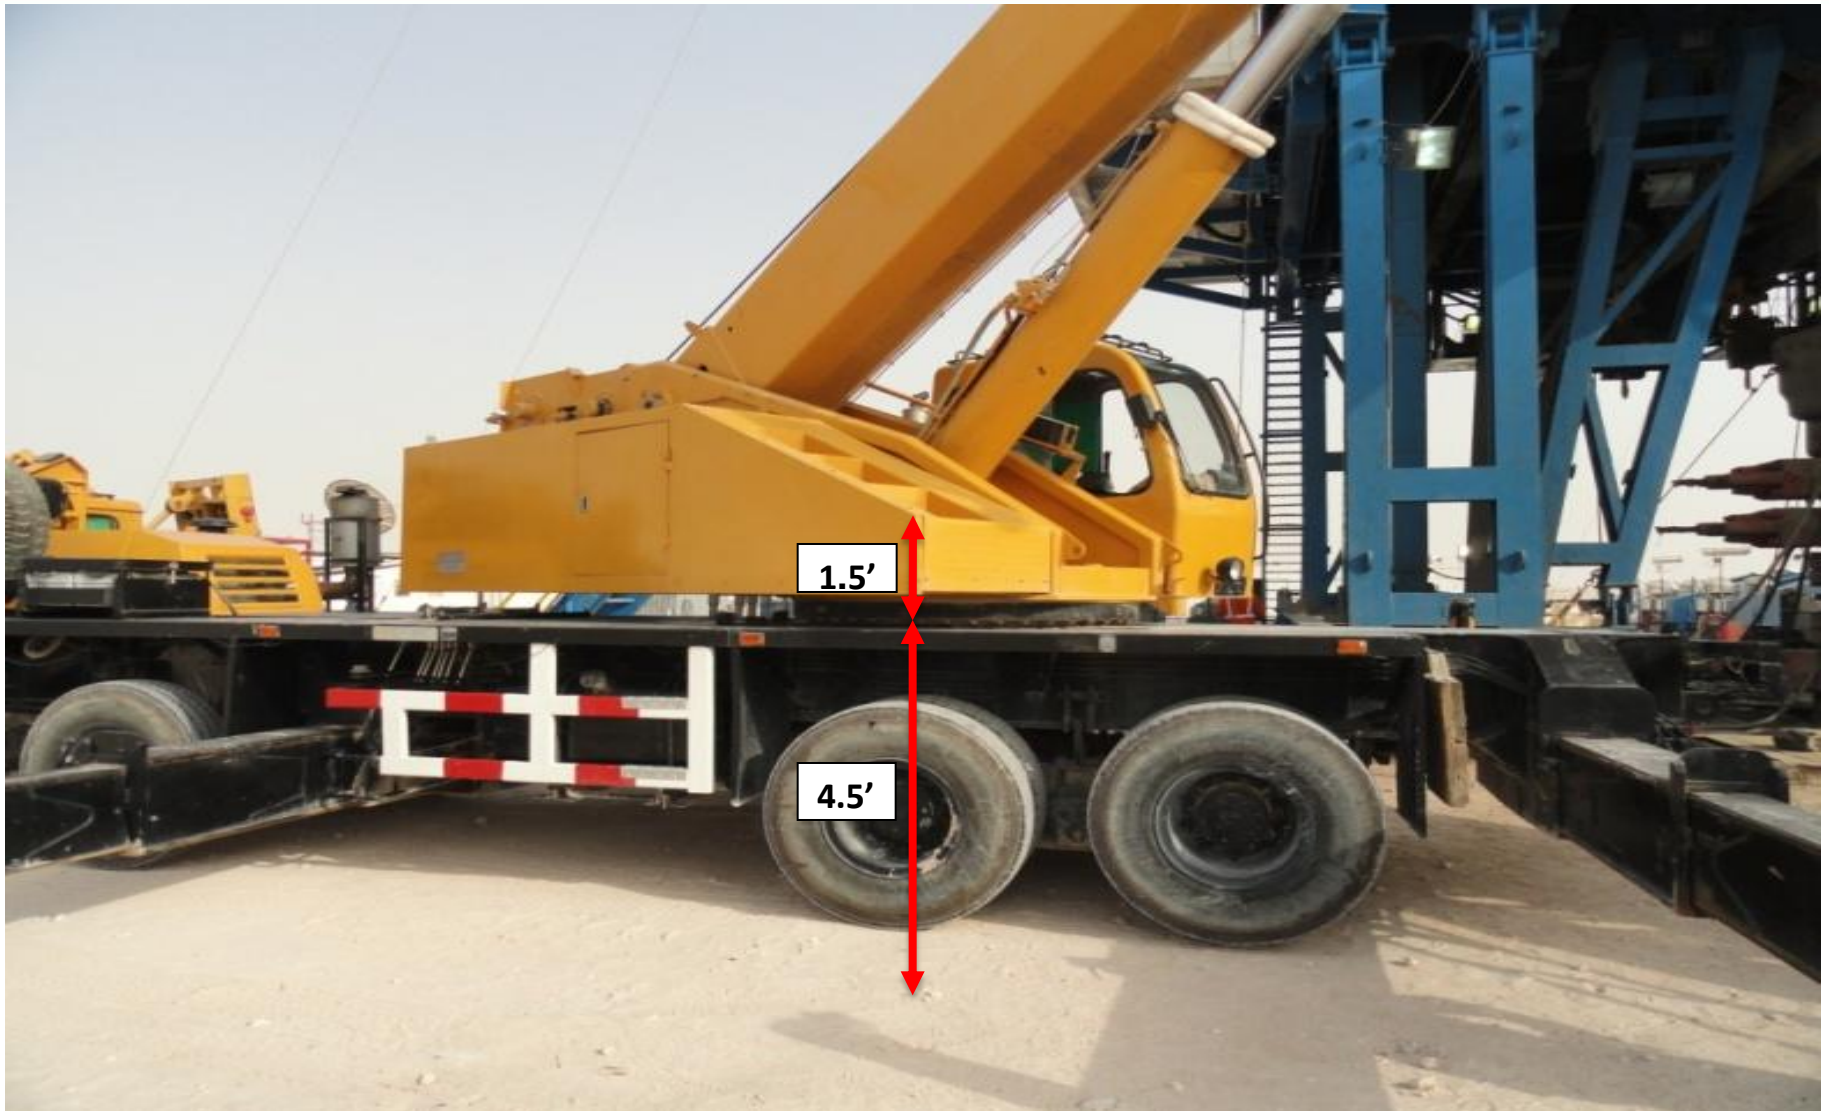
Crane Operator (IP) came out from crane cabin to check the engine and while climbing onto the engine compartment, the IP slipped and fell to the ground.

## Picture 2: Height of fall.

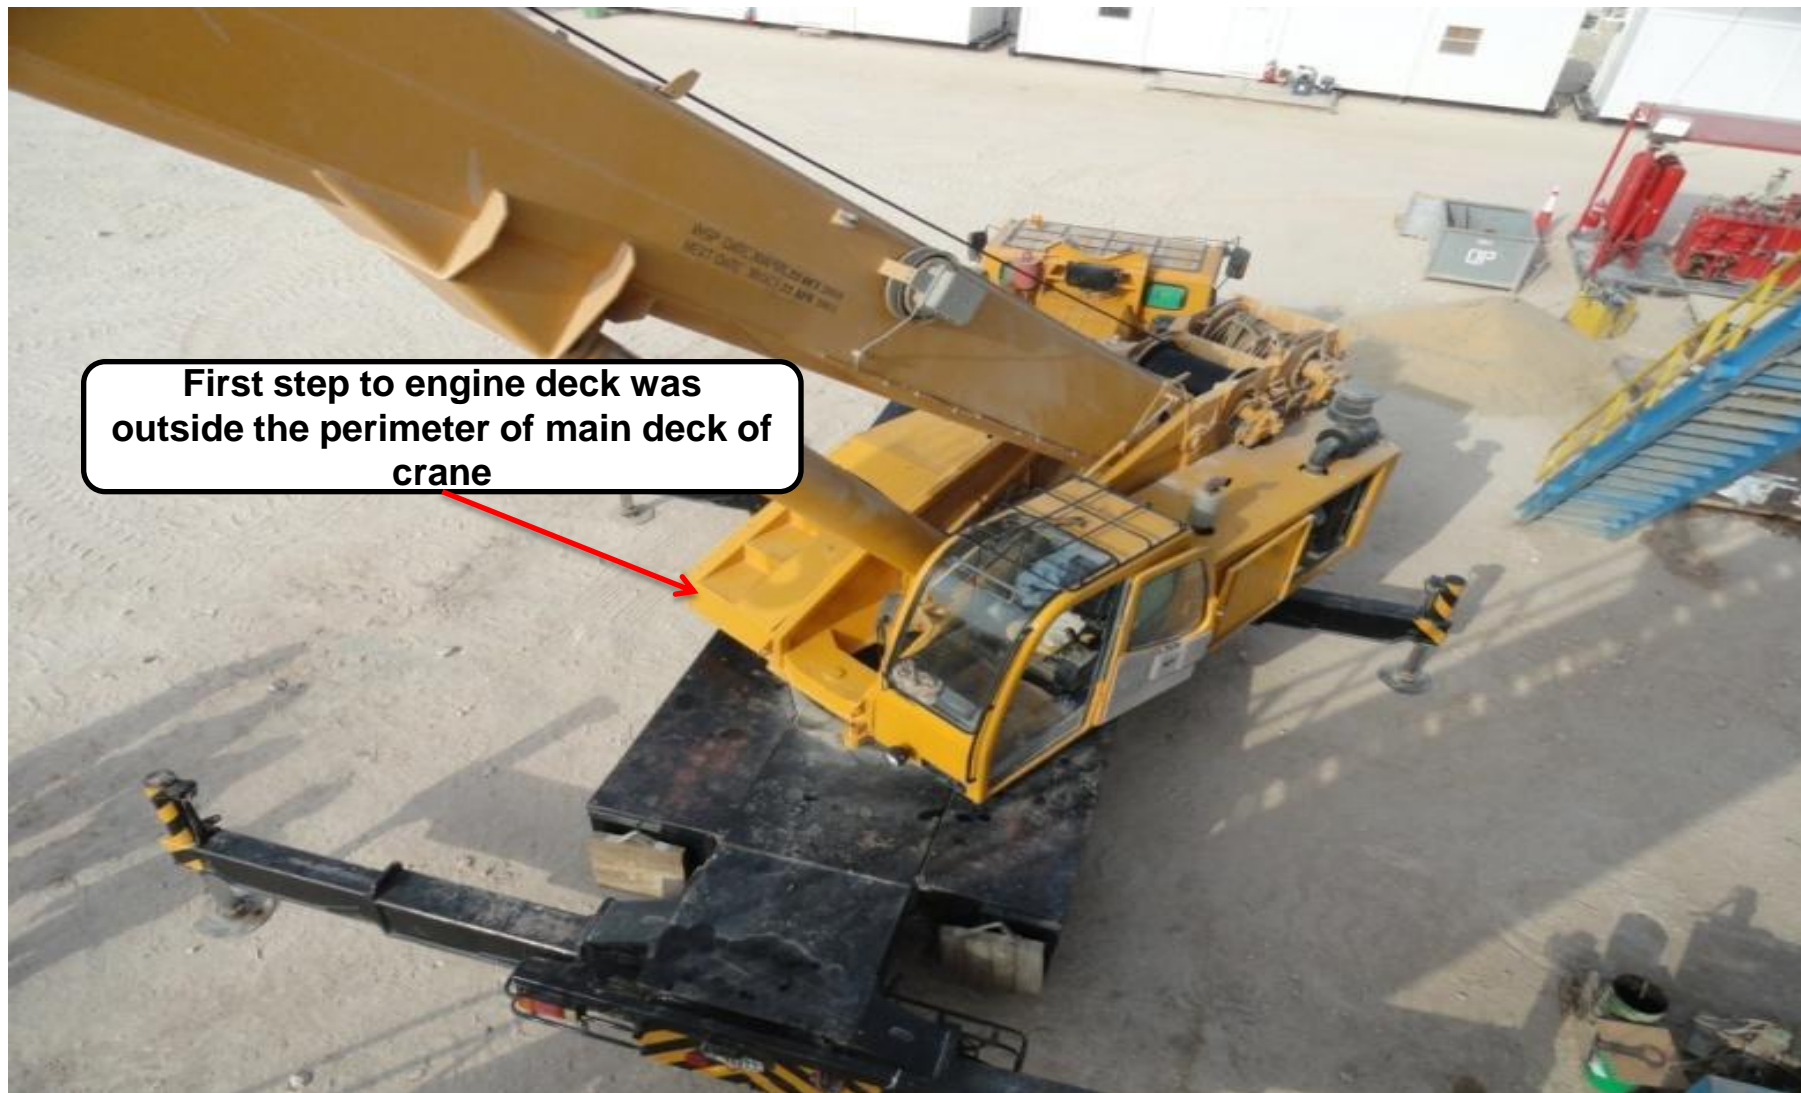
## Picture 3: Misalignment of step against the crane deck.

- Slip.
- Lack of concentration.
- The steps leading to engine compartment was not aligned to main deck of the crane.

- Human error.
- Over-painting on checker plate steps reduced the slip resistance.
- No specific instructions in procedure for the alignment of crane when doing maintenance or when there is need to use the steps leading to engine compartment.
