MAERSK OIL QATAR AS DRILLING DEPARTMENT SAFETY STATISTICS Q2 & Q3 2011

DOIRC Meeting November 2011

Non-Compliant Big Bags Sent to the Rig

Floorman Fell Through Well Slot (03-10-11)

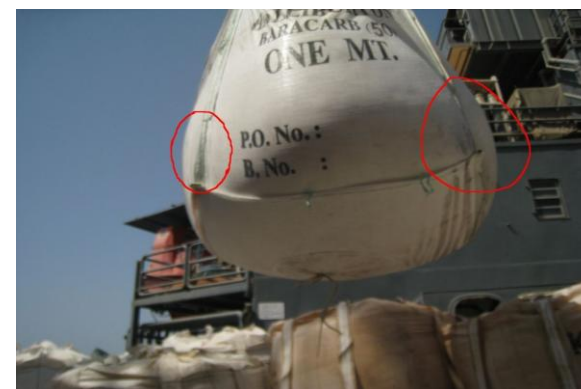
- Non-compliant (lack of continuous straps) big bags of Baracarb were sent to the Rowan Paris

- The Halliburton dispatcher was unaware that the bags were destined for an MOQ operation. The Halliburton warehouseman at Street 24 warehouse received no instructions to re-bag. The shipment was then trucked to the MOQ warehouse where it was not inspected before being shipped to the Rowan Paris. The non-compliance was subsequently identified by the rig crane operator.

- The straps may have parted from the bag resulting in the contents exiting the big bag resulting in injury to personnel or damage to property.

Non-compliant straps

- A dedicated procedure covering big bag dispatch and inspection is now implemented.
- All future shipments to be compliant with EN/ISO 21898.

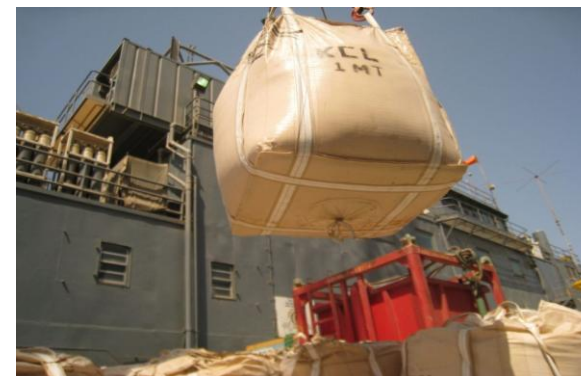
Compliant straps

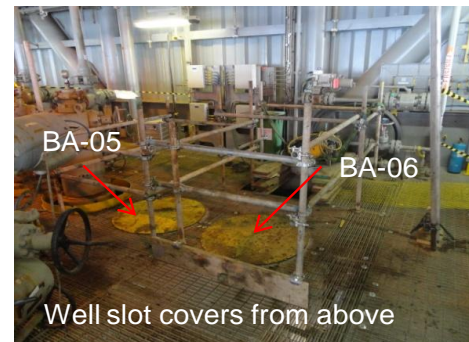
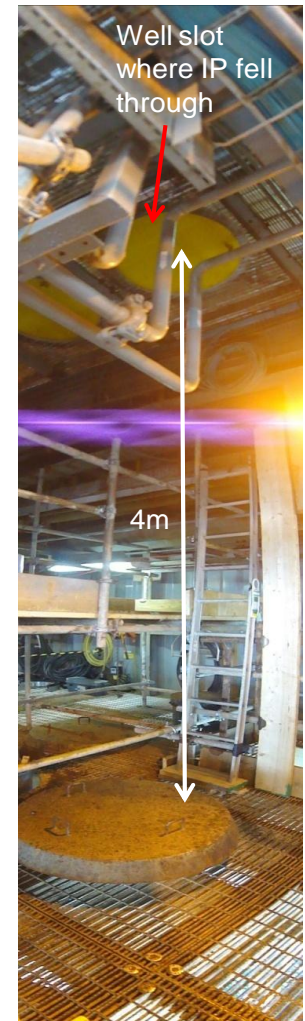
- While repositioning a well-slot cover on the mezzanine deck of BA wellhead platform, 1 of the 2 Floormen performing the task fell through the opening, falling 4 meters to the cellar deck below. The IP sustained a dislocated left shoulder and fractures to his elbow and wrist.

- Scaffolding around hatch covers not perceived as a “barrier”, numerous other scaffolding work ongoing in the vicinity for both Drilling and Production

- No risk perceived in entering inside the “barrier”
- No supervision and no JSA or Toolbox Talk conducted prior to the task in question
- Lack of communication between IP and 2nd Floorman (FM) in handling the hatch cover

- IP unaware there was an opening below the hatch being moved, no markings/warning on cover (IP a relief FM who had not performed the task in question prior to this incident)

- No PTW for the hatch replacement below the main deck (although there was a PTW in place for larger hatch on the main deck)
- No instructions on the need for a safety harness, although the RA for this phase of the operations called for such safety devices to be used for this very purpose

- No specific instructions/PTW on how Construction should erect and identify such barriers

Full TOPSET report with recommendations available in Synergi, Case # 1721
