# RasGas Sub Surface Safety Stats Q2 2011 & Q3 2011

## Incident Investigation Report

**Description:** IP's hand pinched in-between rig tong  
and drill pipe in mouse hole

**Description:** IP's hand impacted and cut by BOP kill line hose flange

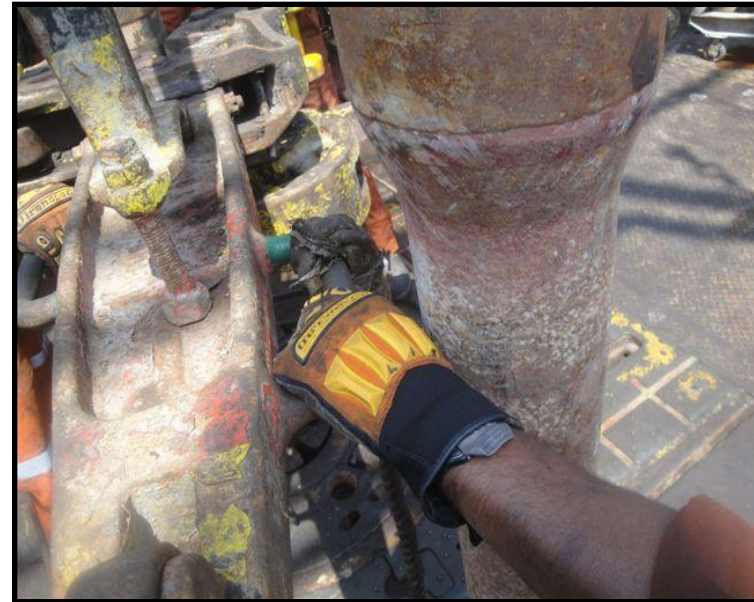
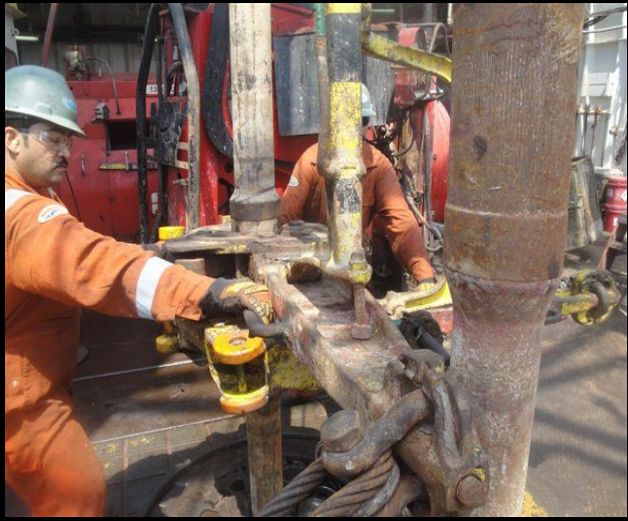
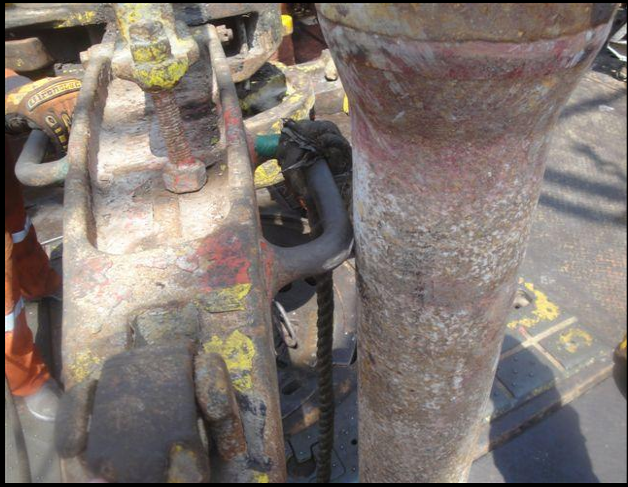
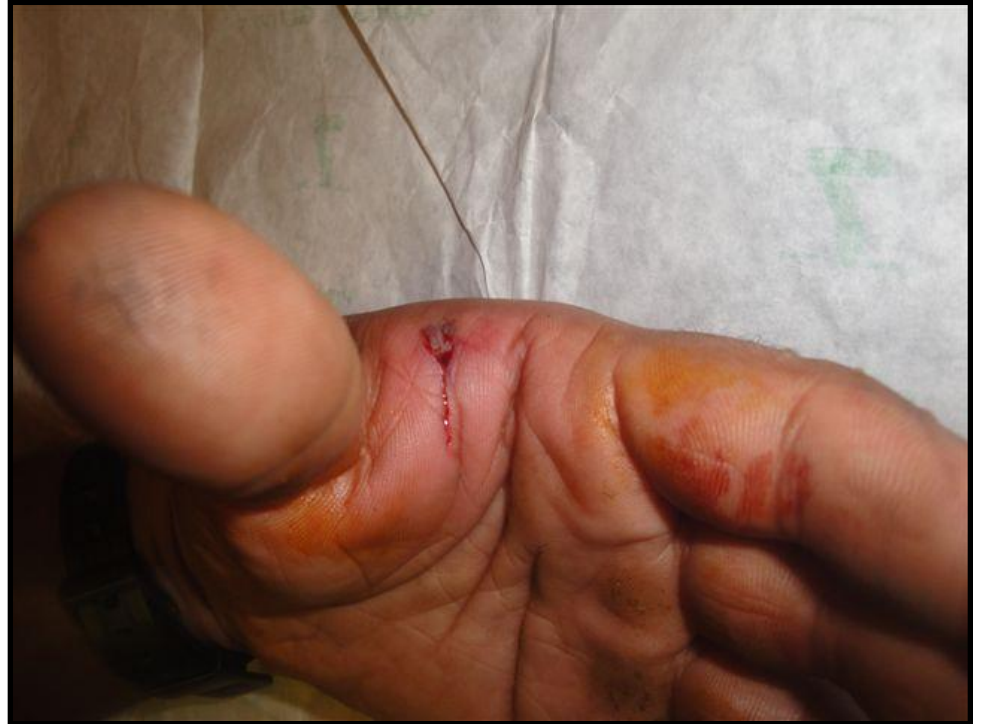
- Reviewed Work Instruction and JSA for picking up drill pipe with ST-80
- ST-80 hydraulic hose failed and the decision was made to complete picking up pipe with Rig tongs
- JSA was then held with crew on picking up drill pipe with the rig tongs
- The crew picked up 3 joints with no issues, only two roughnecks were handling the tongs at the time
- The crew picked up the 4<sup>th</sup> joint, made up with chain tongs, and installed rig tongs on the pipe in the rotary hole
- The IP (Floorhand) attempted to help the man working on the makeup tong by pulling the tongs around from the back handle
- The IP got his hand caught in-between the tong handle and joint of drill pipe in the mouse hole
- IP's hand got pinched causing ½" cut on hand between index finger and thumb
- IP was wearing new technology Kong Gloves at the time of incident

- Equipment failure gave the chance to switch to other manual handling equipment
- Unreasonable increasing the possibility of hand injury by handling manual equipment
- Crew did not recognize or identify potential hazard of tongs striking pipe in mouse hole
- Work instruction available for picking up pipe with ST-80 but none available for picking up pipe with rig tongs
- Snub line in use was excessive in length for picking up pipe in mouse hole

- Whenever the ST-80 is estimated to be down for up to 2 hrs and with no open hole issues, then the OIM will decide to stop the operation and fix the ST-80 and not to switch to rig tongs, signage will be posted stating the same
- Change out all critical hoses on the ST-80 during a 12 month rolling period
- Develop WI for picking up drill pipe with rig tongs and send to Rig Manager for approval
- Change snub line of makeup tong from 8.5' to 7' Signage to be made and installed in the driller cabinet stating: "Driller's responsibility to ensure only 7' snub-lines or shorter to be used on rig makeup tong, toolpusher to be informed when changing the snub line"

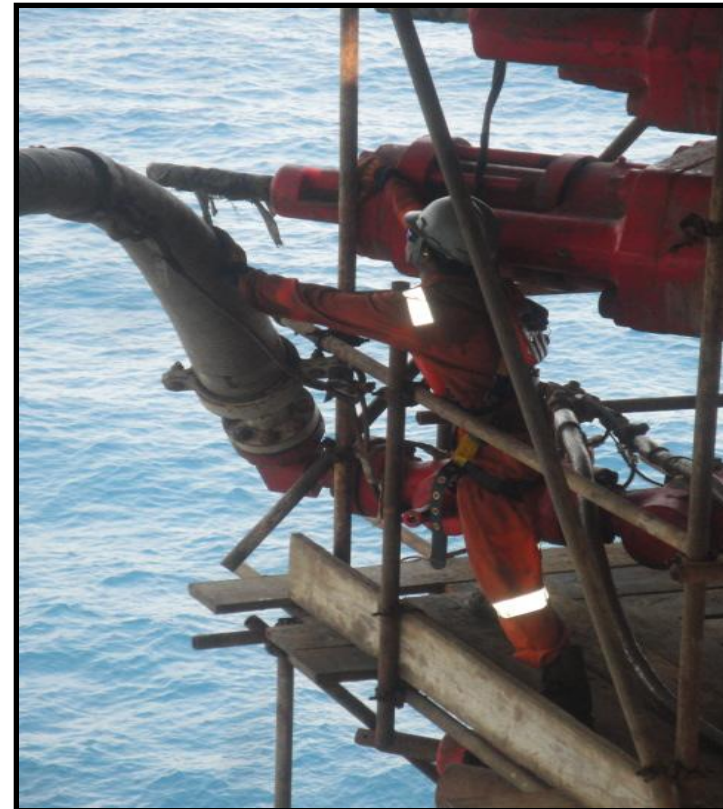
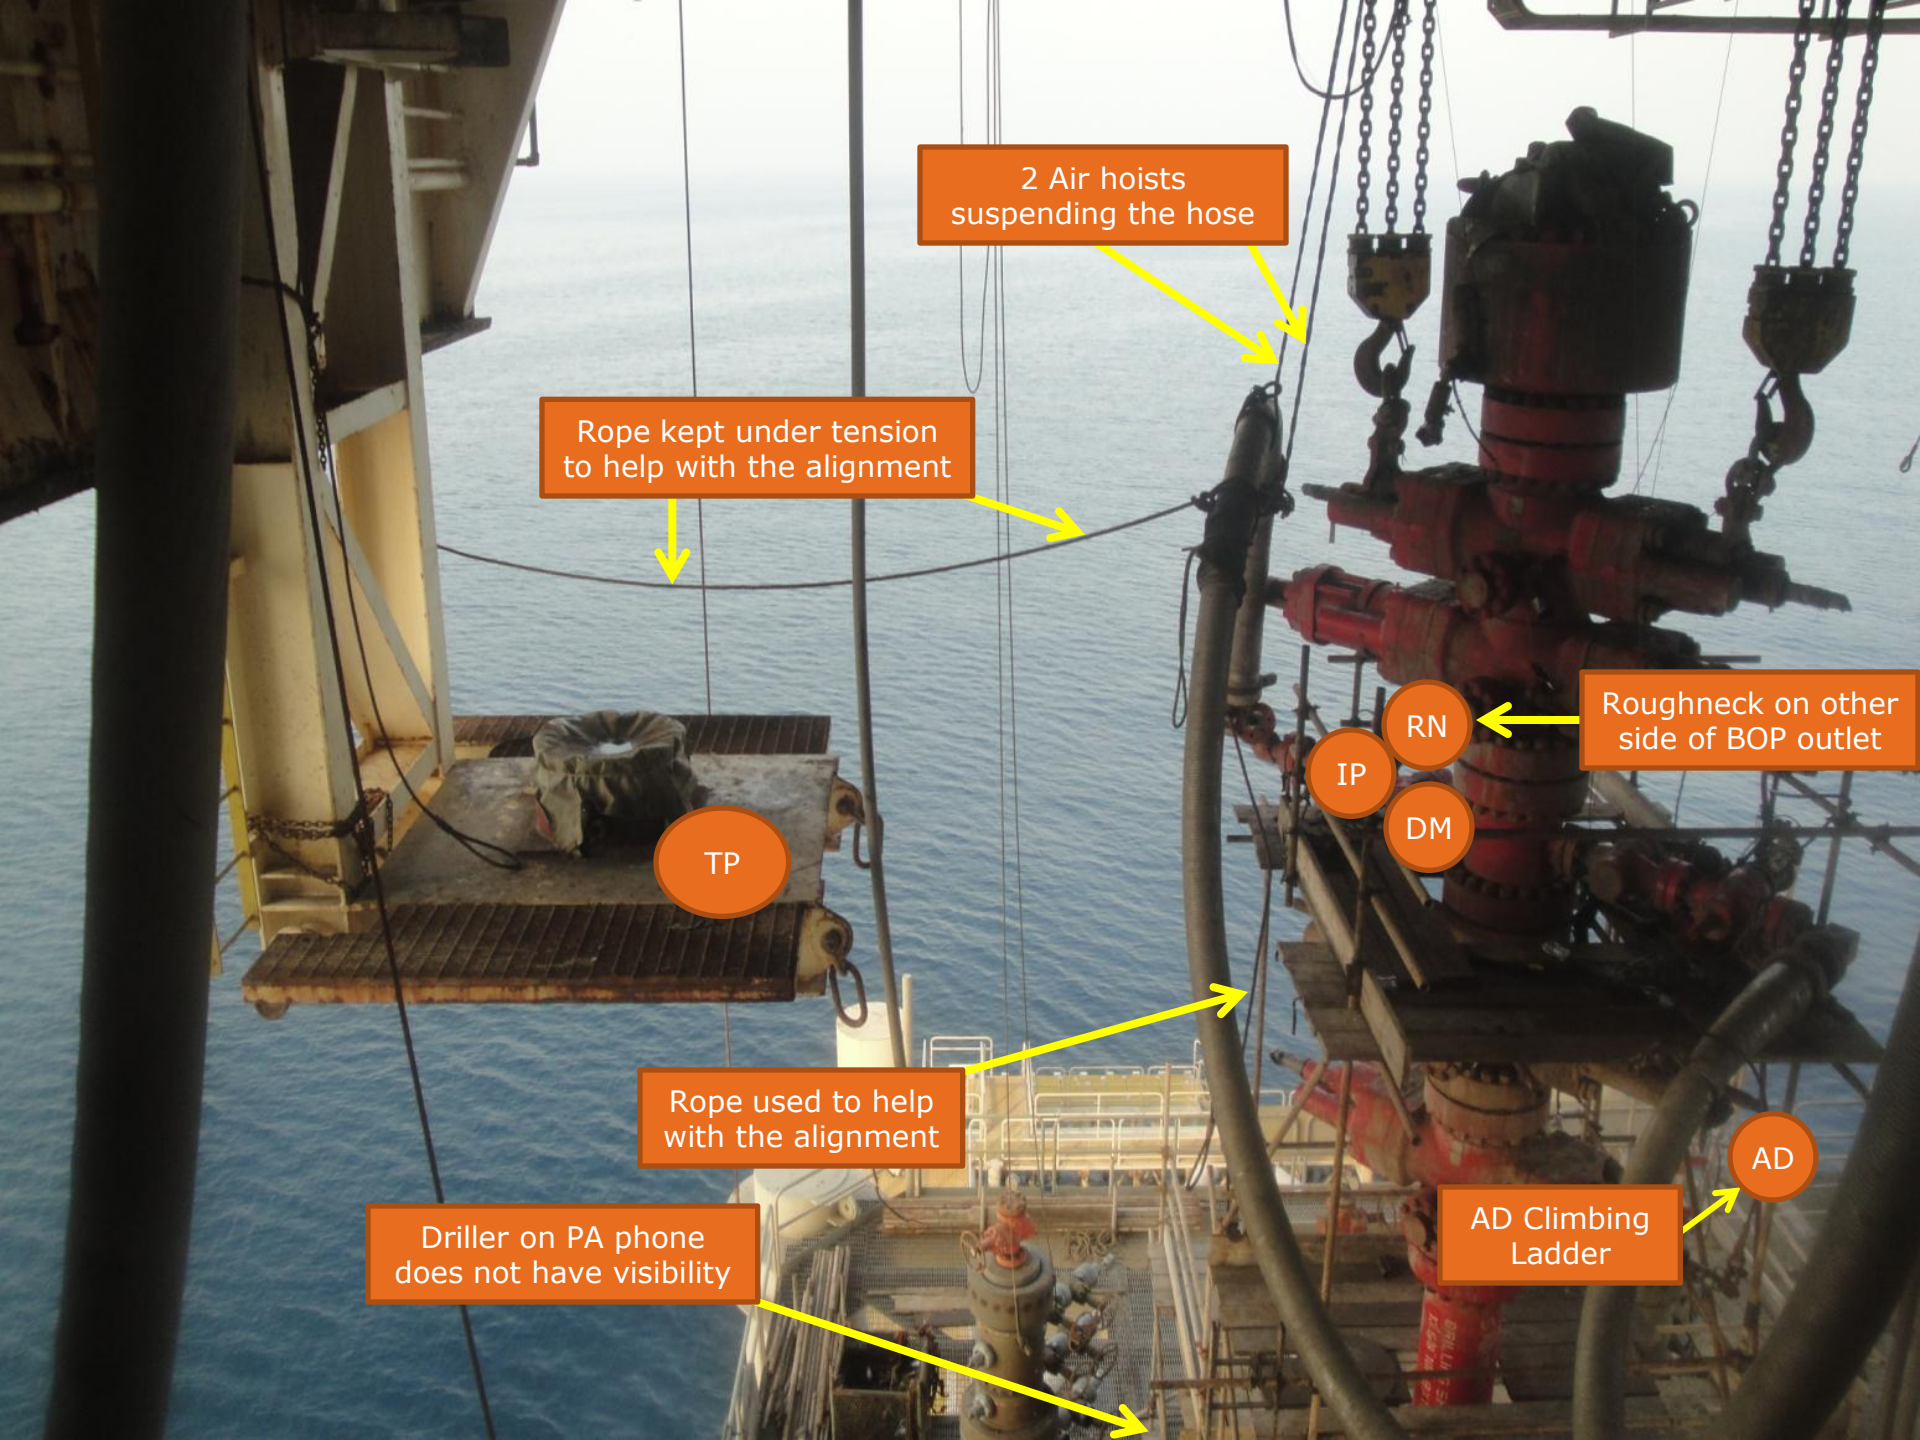
- Drill crew was connecting kill line hose to HCR valve flange
- After positioning Kill line hose flange over kill line HCR connection, a bolt was started into the flange
- Crew was attempting to tap bolt into the flange with a 2 lb. hammer
- Kill line came off flange connection and swung towards BOP resulting in Floor man's finger being pinched between kill line and BOP ram bonnet causing a severe laceration on base of IP's right ring finger
- Job was stopped and IP taken to medic, wound was cleaned and dressed. IP accompanied by Ensco Rig manager on Medevac to hospital in Doha
- Injury was evaluated by doctors, X-rays were negative for fracture and nerve damage, wound was closed with 4 sutures and dressed with bandage
- IP released for restricted duty and returned to rig on 8<sup>th</sup> August 2011

2 Air hoists  
suspending the hose

Rope kept under tension  
to help with the alignment

Roughneck on other side  
of BOP outlet

Rope used to help  
with the alignment

Driller on PA phone  
does not have visibility

AD Climbing  
Ladder

- JSA procedure was not being followed properly and a corrective action to address this was not implemented successfully
- The hook up of both the choke and kill line is extremely difficult, yet the rig has not tried to address this by engineering out some of the problems and making it less hazardous
- Work Instruction used for connecting the choke and kill hoses specifically identify that hand placement and hand injuries are hazards that must be mitigated against, but it was not used during the JSA
- Unsafe rig up for the operation which created the stored energy in the hose when it jumped and impacted the IP's hand

- Full independent review of the choke and kill hose installation to be performed and all recommended additional equipment required to make this operation both safer and easier will be implemented
- All Supervisors and Crew Members will be re-trained in requirements of the JSA procedure. The leader for each of these training sessions will be the OIM assisted by the Toolpusher. Delegation of this training leadership will not be permitted
- Laminated copies of the Rigs, Work Instruction Index will be posted in the changing room and on the drill floor
- Key high risk operations will be audited by the OIM and Night Toolpusher to ensure complete compliance with the Ensco Safe Systems of Work
