HSE Incident  
Near-miss  
Sinkerbar dropped to rig floor

4<sup>th</sup> Nov 2009

## Sinker Bars Drop to RF During Fishing Job – 12 Aug 2009 – Roger Lewis

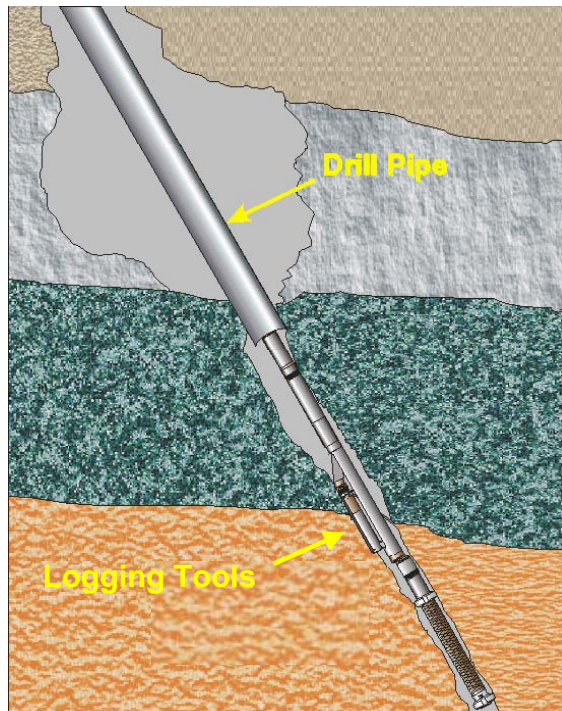
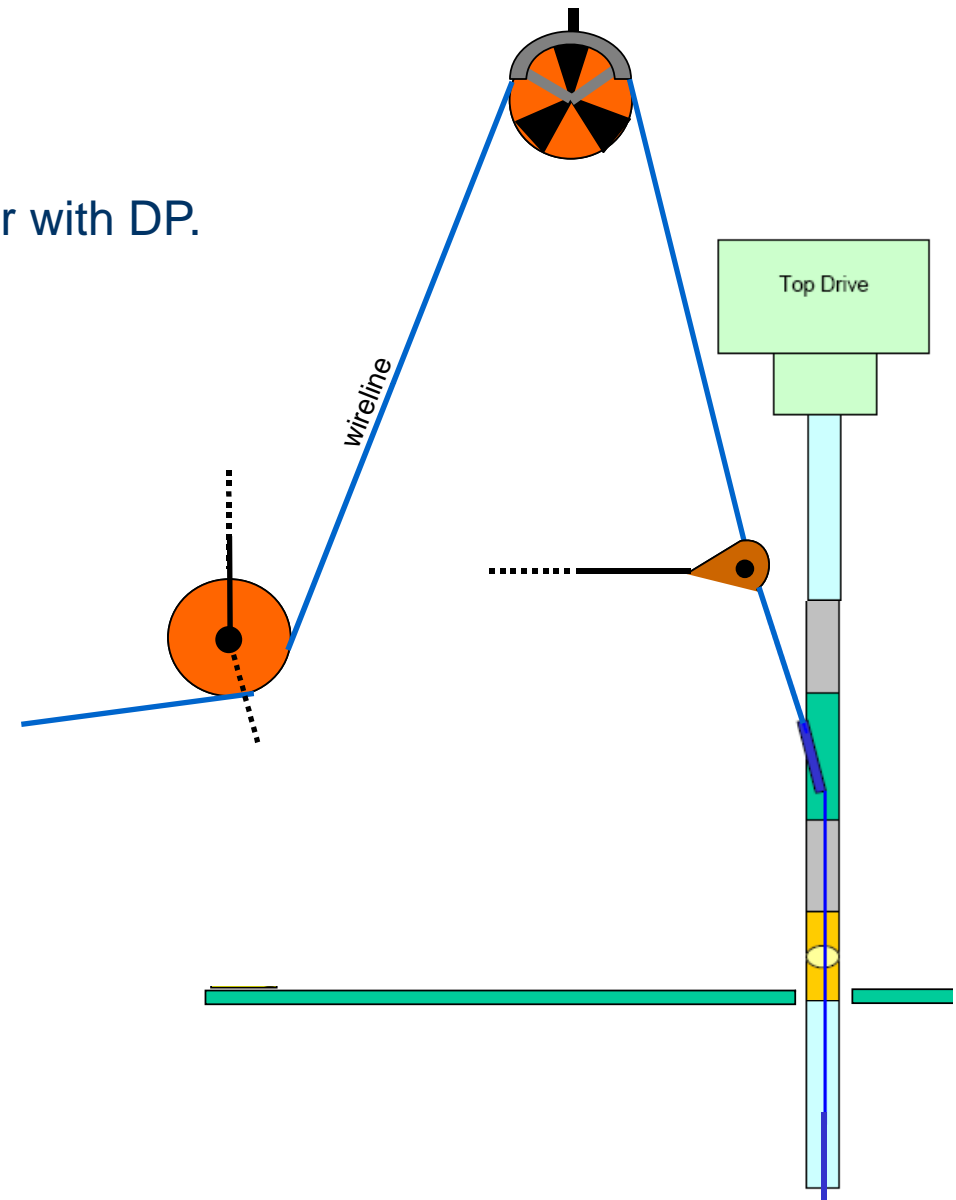
- Rigged up for through-pipe logging.
- Logging tools got stuck, washed over with DP.
- Tools unable to move free in DP.
- Reverse cut and thread.

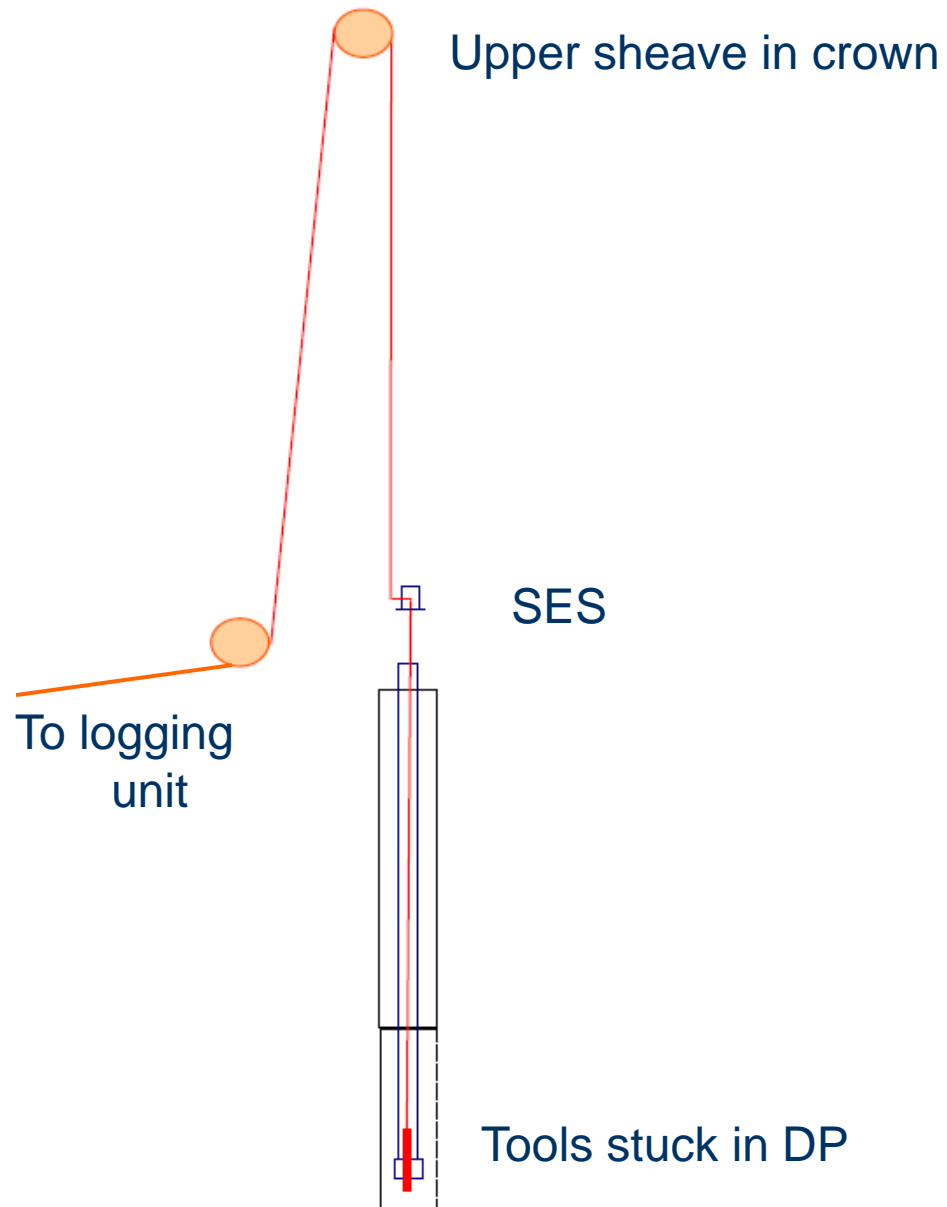
- SES back at surface.
- Start reverse cut and thread
- Automated rig.
- No derrickman.
- Logging contractor's fishing kit does not have sinkerbars for reverse cut and thread.
- Contractors procedure is to pull cable without weights while disconnected stand is in the mousehole.
- This does not work on an automated rig → procedure was modified.

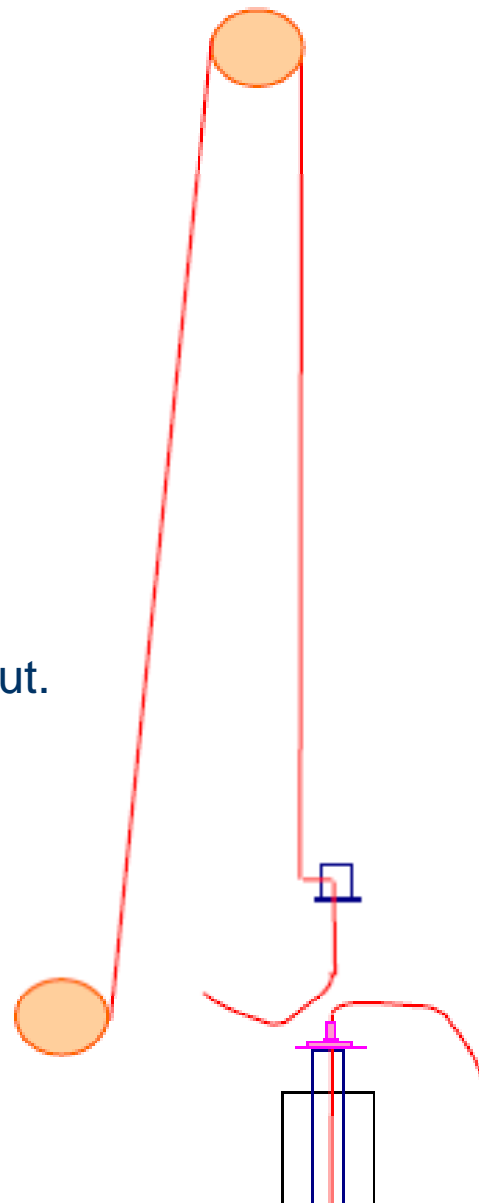
Clamp wire and cut.

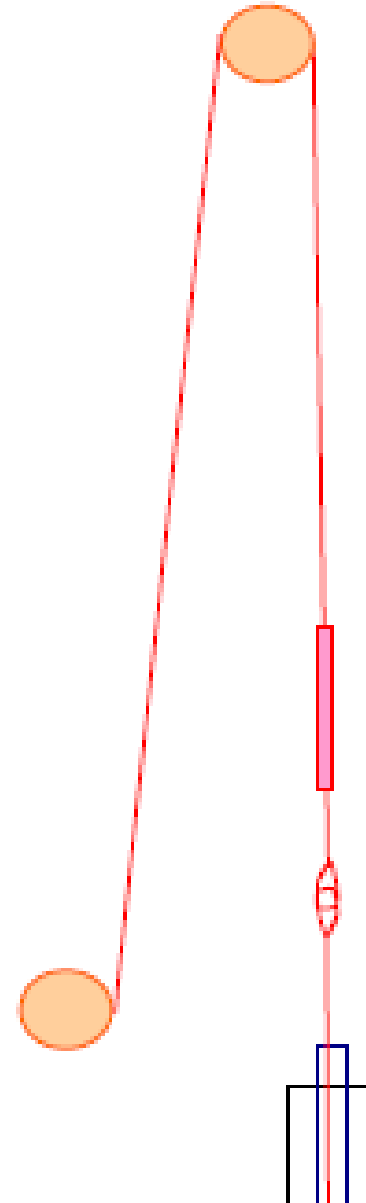
Remove SES, install sinker bar, clamp wire, pull tension, remove clamp and c-plate.

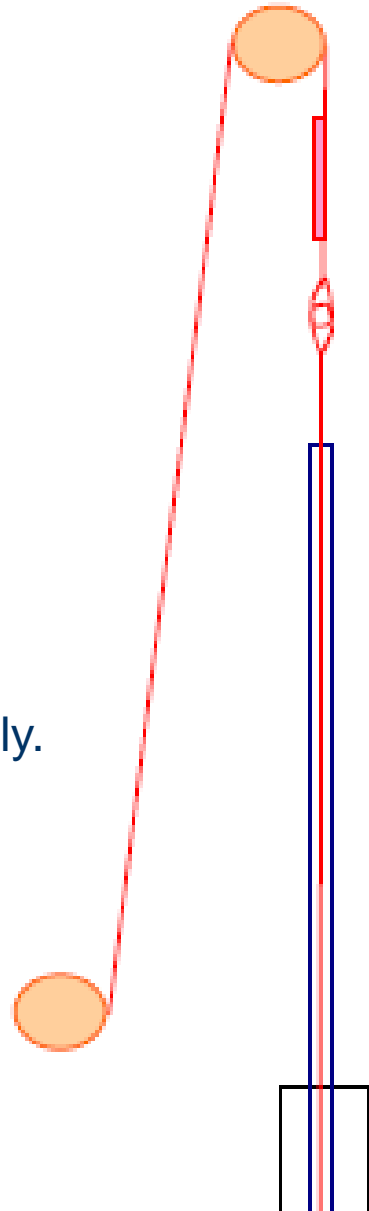
Pull stand and wireline simultaneously.

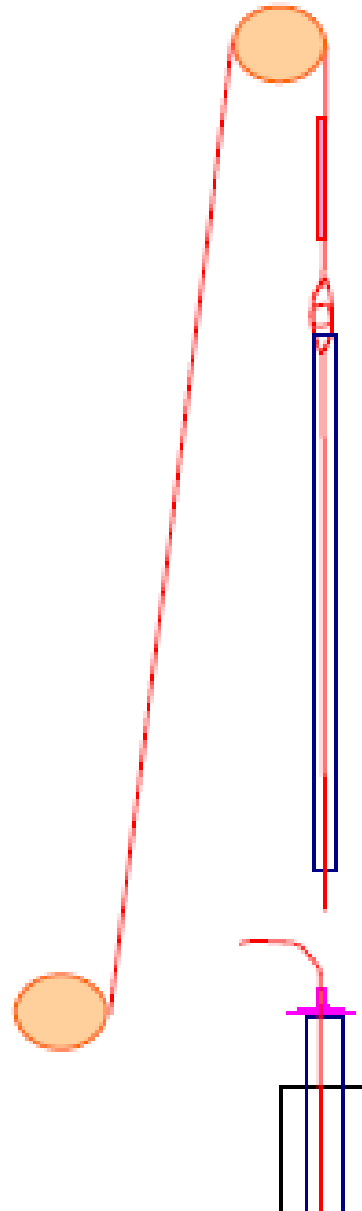
Disconnect stand, lift stand, clamp wire, cut wire.

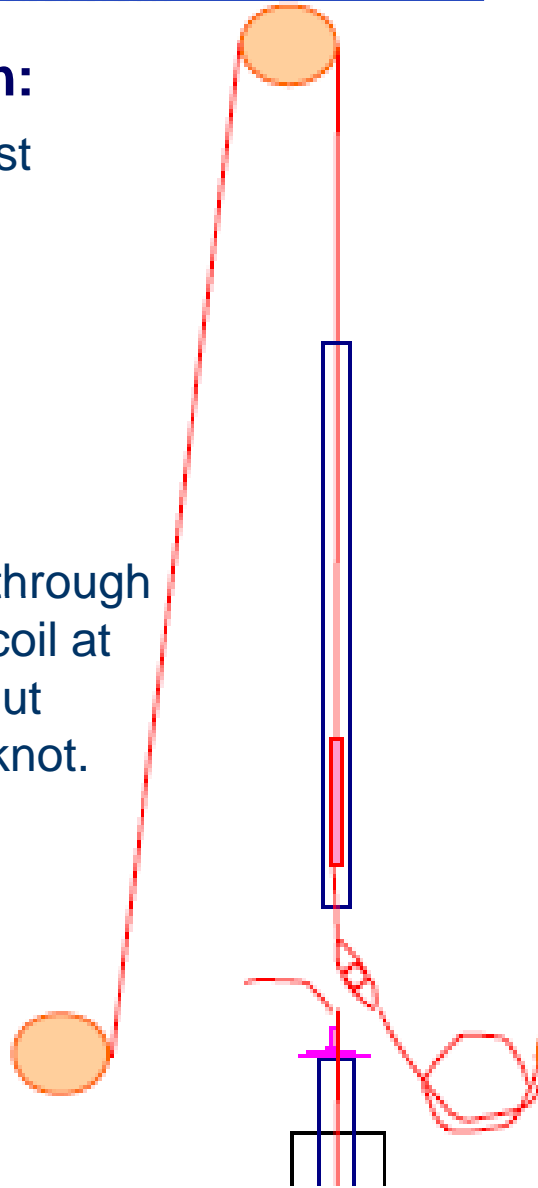
Lower cut wire through string and coil at drill floor. Cut above the knot.

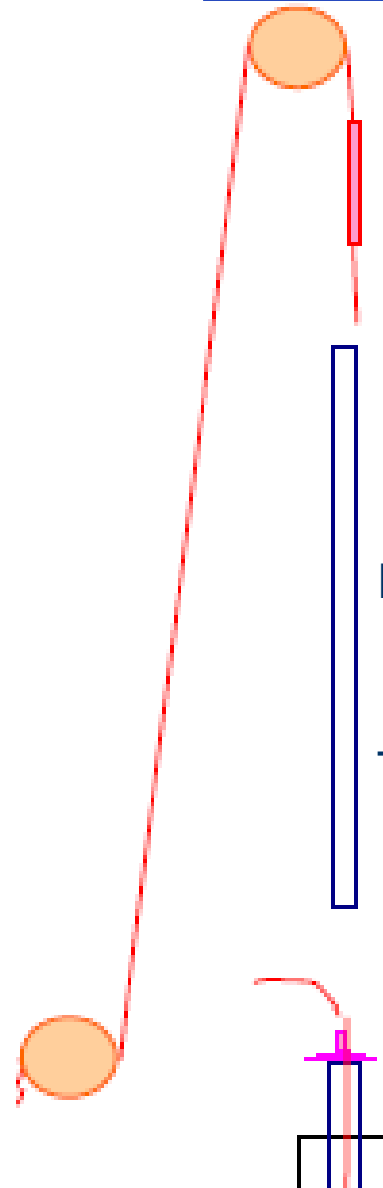
Pull the wire and sinker bar above the stand of drillpipe.

Then rack back the stand and bring the sinker bar down to the DF to start again.

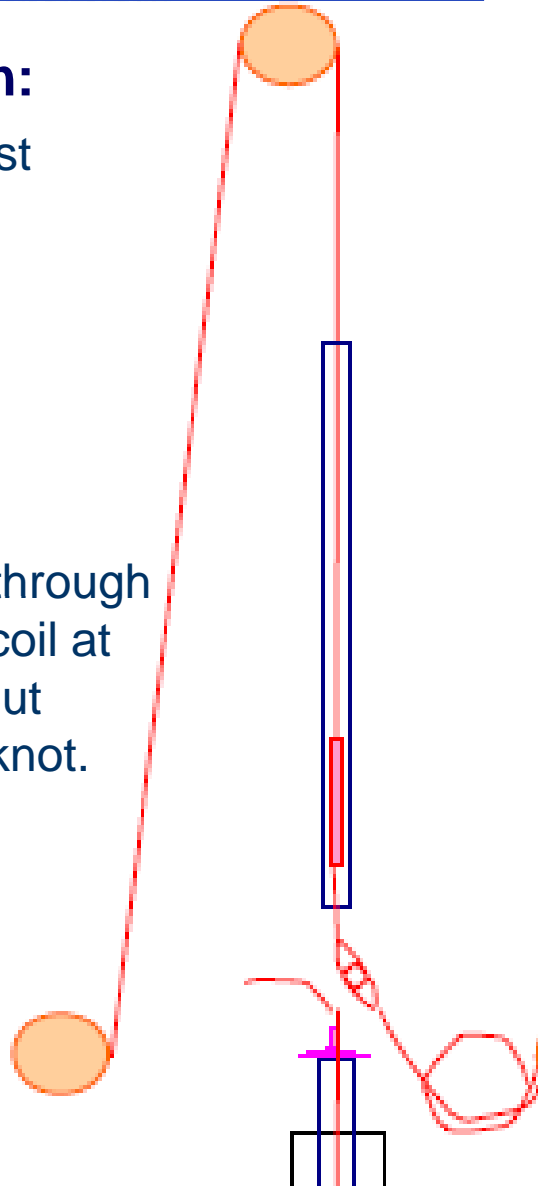
Lower cut wire through string and coil at drill floor. Cut above the knot.

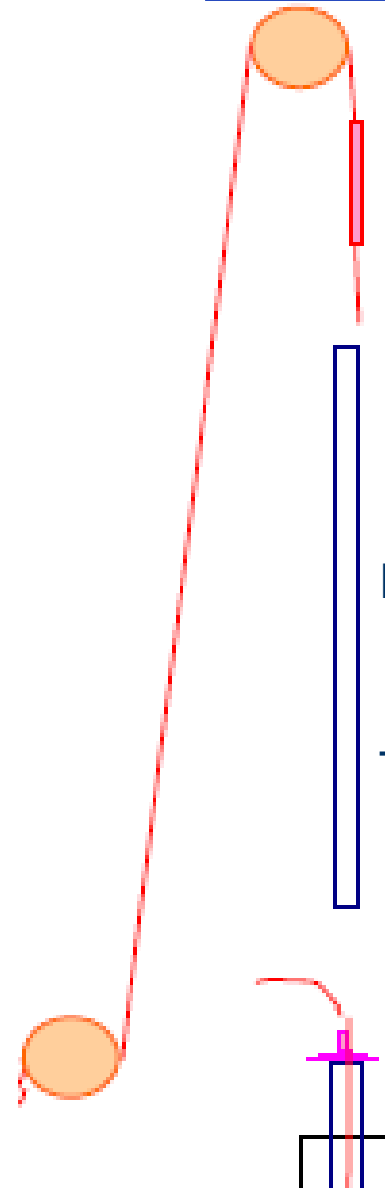
This is when the incident happened.

Pull the wire and sinker bar above the stand of drillpipe.

Then rack back the stand and bring the sinker bar down to the DF to start again.

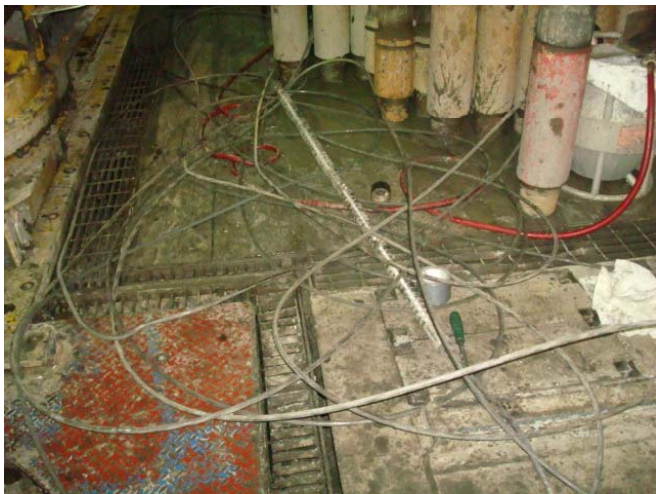
- When the sinker bars cleared the top stand, they kept moving upwards, cleared the top sheave, dropping 160 ft to the drill floor.
- All staff had cleared the rig floor prior to the sinker bars hitting the rig floor.

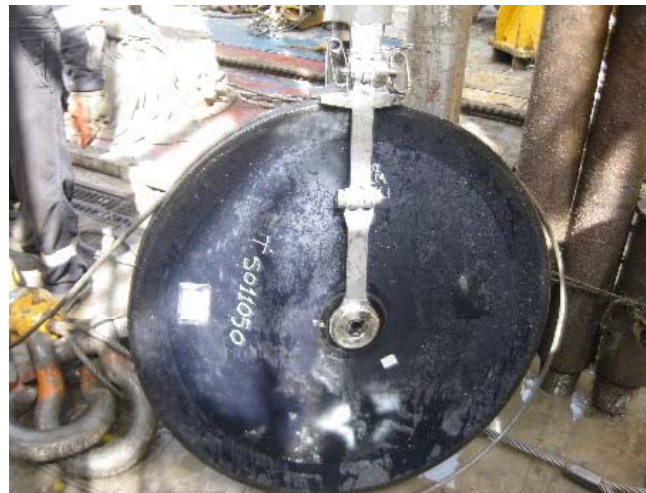
Wireline cable /w TLC pump-down bar on DF

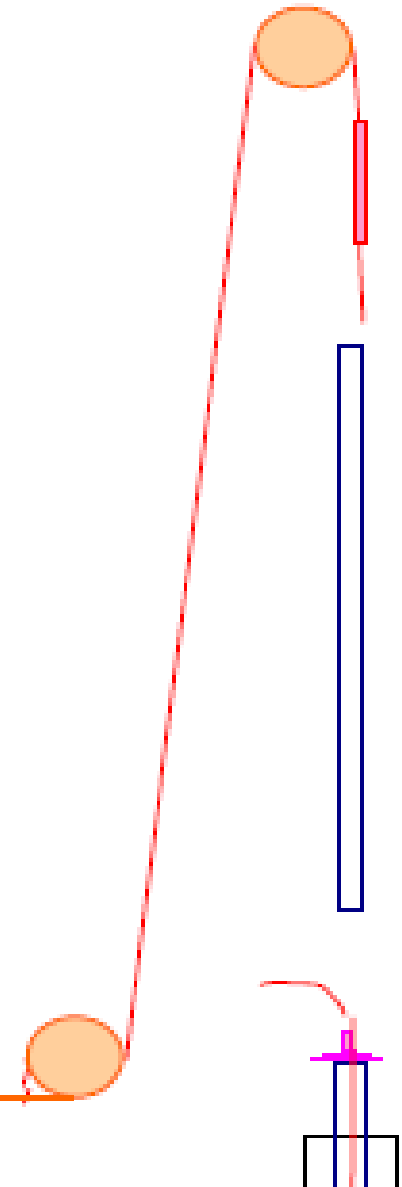
Unguarded crown Sheave

- Fishing equipment onboard recently changed and not suitable for developed reverse cut & thread procedure: no weight bars available; used TLC weight bars instead.
- No contractor-derived fishing procedures available at the time of this operation. Those provided after incident were designed for a rig with a manual derrick, where the cut cable is pulled without weights while DP in mousehole.
- No consideration was given to do a weight calculation for both sides of the sheave (ended up 15 lbs light on DF – crown side).
- Upper sheave had no guards to prevent weight bars spooling over it.

- Review fishing procedures (both c&th and reverse c&th) for rigs with automated equipment.
- Developed specific procedures for fishing equipment and rig equipment.
- Rig fabricated a bar weighing 150 lbs to over-balance the newly calculated opposing wireline cable weight.
- Weight bar has no-go ring to prevent it being spooled over the upper sheave.
- Guard for upper sheave will be fabricated

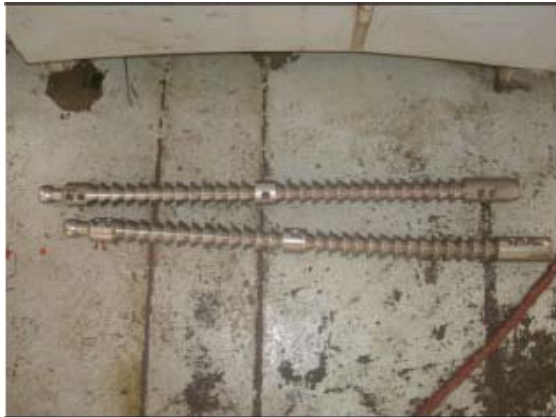
TLC pump down bars (picture 1)

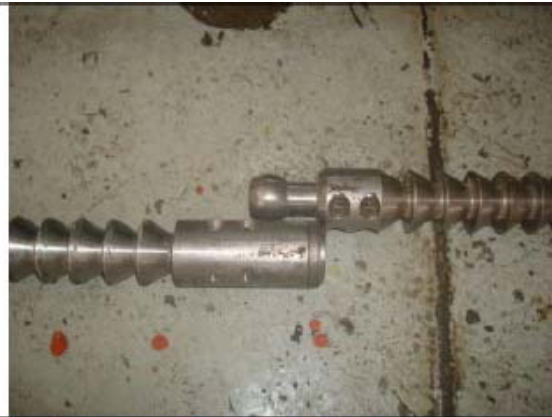
TLC pump down darts (Picture2)

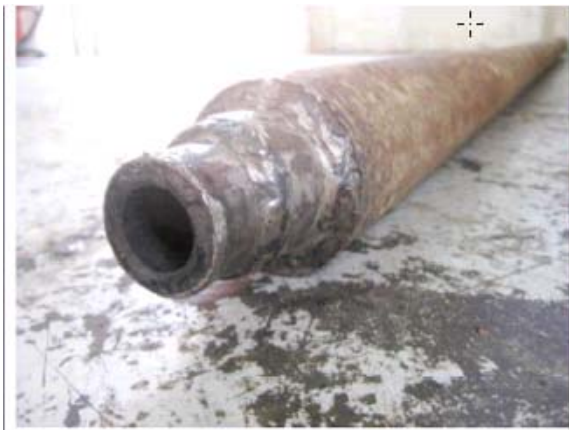
New Sinker Bar 150 lbs

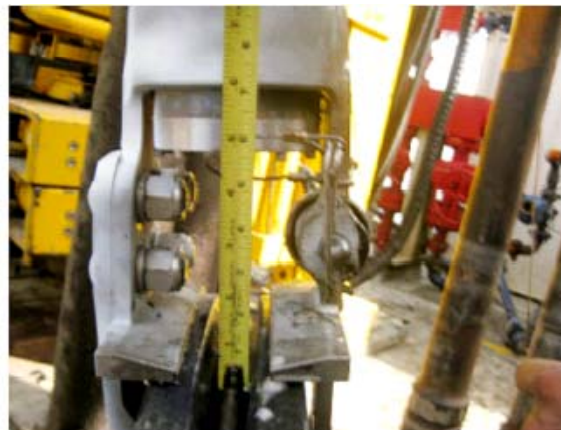
New sinker will not fit through top sheave

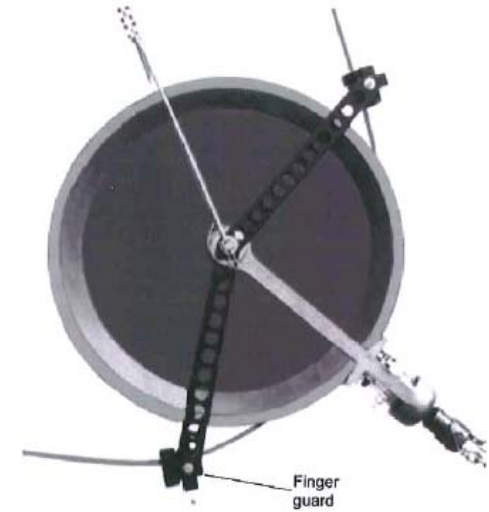
Figure 4 : Lower Sheave Wheel with Finger Guard
